City of Westmount

Heritage Character Defining Elements:
Category 1★ Buildings

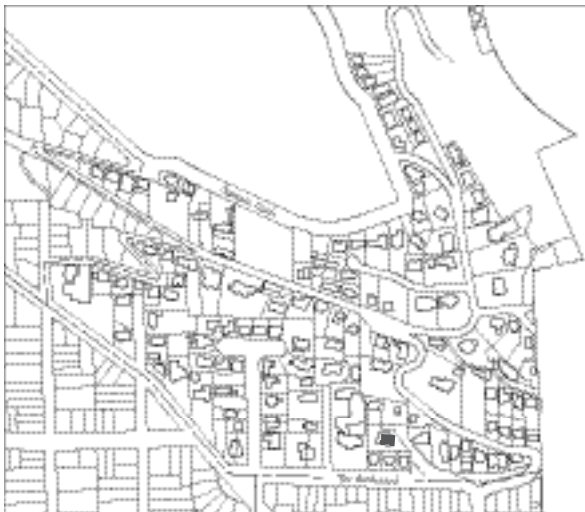
<i>Description:</i>	A detached house where all 4 façades are of importance. However, the south (principal) and east (street) façades are more articulated and of greater architectural value. Heritage value derives from Historic Value, due to its age; to its Artistic Value as a work by William Footner, the architect of Bonsecours Market and then Barott and Blackader, and as almost intact example of a neo-classical villa of the mid 19th century. Braemar is a classified monument (MCCCCFQ)
<i>Date of construction:</i>	1849; alterations in 1924, 1963, 1964, 1967, 1974
<i>Persons associated with:</i>	John Eadie, Owner; William Footner, Architect; Barrot and Blackader, Architects (galleries)
<i>Stylistic influences:</i>	Neo-Classical
<i>Materials:</i>	
<i>Cladding (HCDE):</i>	Brick
<i>Roof (HCDE):</i>	Standing seam metal
<i>Windows (HCDE):</i>	Wood; original
<i>Woodwork (HCDE):</i>	Wood Galleries wrap around the building on all four sides and on both storeys. Although the galleries are not original, they are now over 80 years old and designed by a respected firm of architects. Furthermore, no archival evidence exists for the original appearance of the house.

<i>Composition:</i>	All façades are symmetrical. Chimneys were at one time symmetrical elements of importance to the overall composition. However, they have been modified. Similarly, dormers have been added to the roof, resulting in un-symmetrical conditions.
<i>Integrity:</i>	High, although maintenance is needed. Unfortunately, integrity of original site has been greatly compromised.
	NOTE: All archival indications are that the galleries are not original to the building, but were added in the 1920s by Barott and Blackader, themselves distinguished architects. Before any work is done on the galleries, archival and on-site research should be conducted to determine what is original to the Barott and Blackader work and what has been added/modified due to repair campaigns.

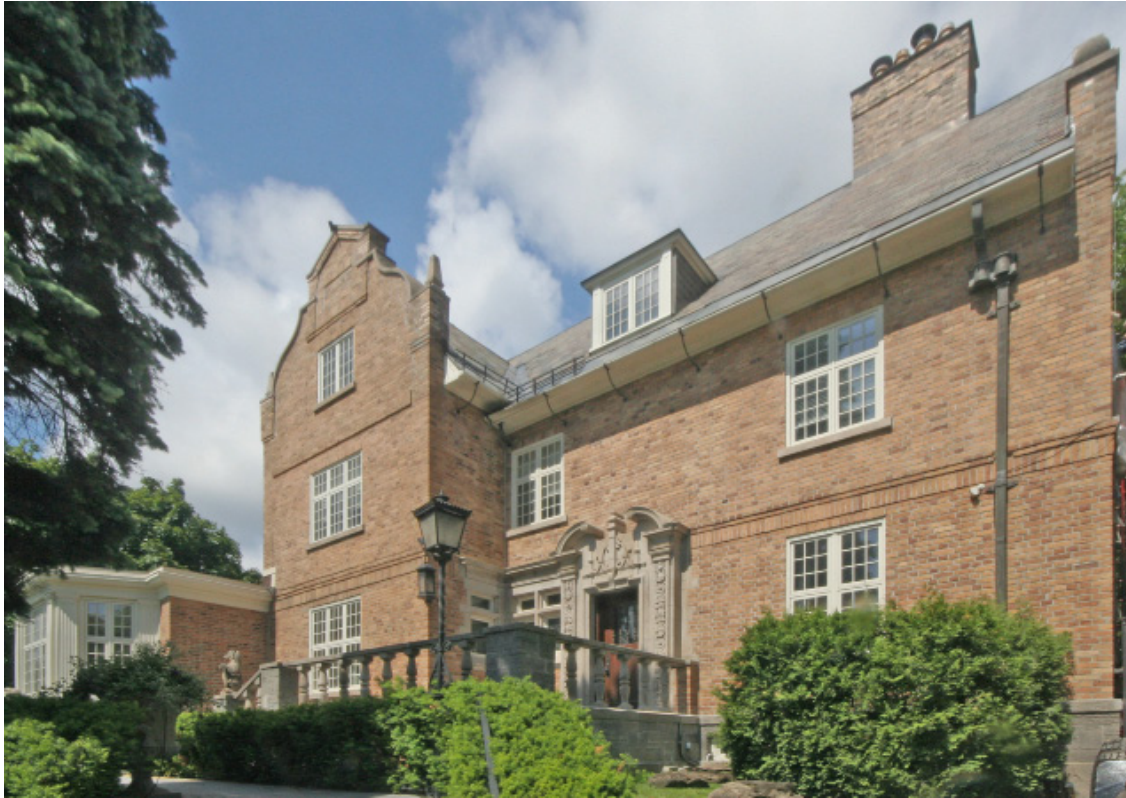
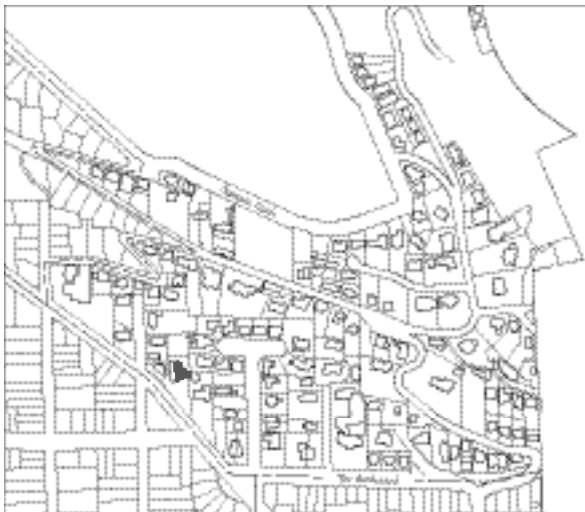
3637 The Boulevard

<i>Description:</i>	A detached house where all 4 façades are of importance. However, due to the swimming pool extension, most significant façades are the south (principal) and east façades. Heritage value derives from Artistic Value, related to its architects, dominant setting in large garden; Queen Anne Revival style, with Picturesque massing and varied roofline.
<i>Date of construction:</i>	1911, modifications or additions 1923, 1975, 1980
<i>Persons associated with:</i>	George Hogg, original owner; Hutchison Wood Miller, architects; Melville Miller, architect; David, Boulva, Cleve, architects
<i>Stylistic influences:</i>	Queen Anne Revival; neo-classical elements
<i>Materials:</i>	
<i>Cladding (HCDE):</i>	Brick; stone portico with broken pediment at front door; Dutch gable with stone enrichments
<i>Roof (HCDE):</i>	Slate
<i>Windows (HCDE):</i>	Wood; original
<i>Woodwork (HCDE):</i>	Contributes to overall variety and richness of detailing; 1980 extension which is visible from the street on the west side and which wraps around the rear façade of the building is a significant intrusion in the composition.

<i>Composition:</i>	In keeping with the Queen Anne Revival, all façades are non-symmetrical; this irregularity is an important HCDE.
<i>Integrity:</i>	Varied: portions of the house appear to be original. However, there has been significant loss of integrity to the west and north, where the swimming pool extension is built.
	NOTE: garden setting important HCDE

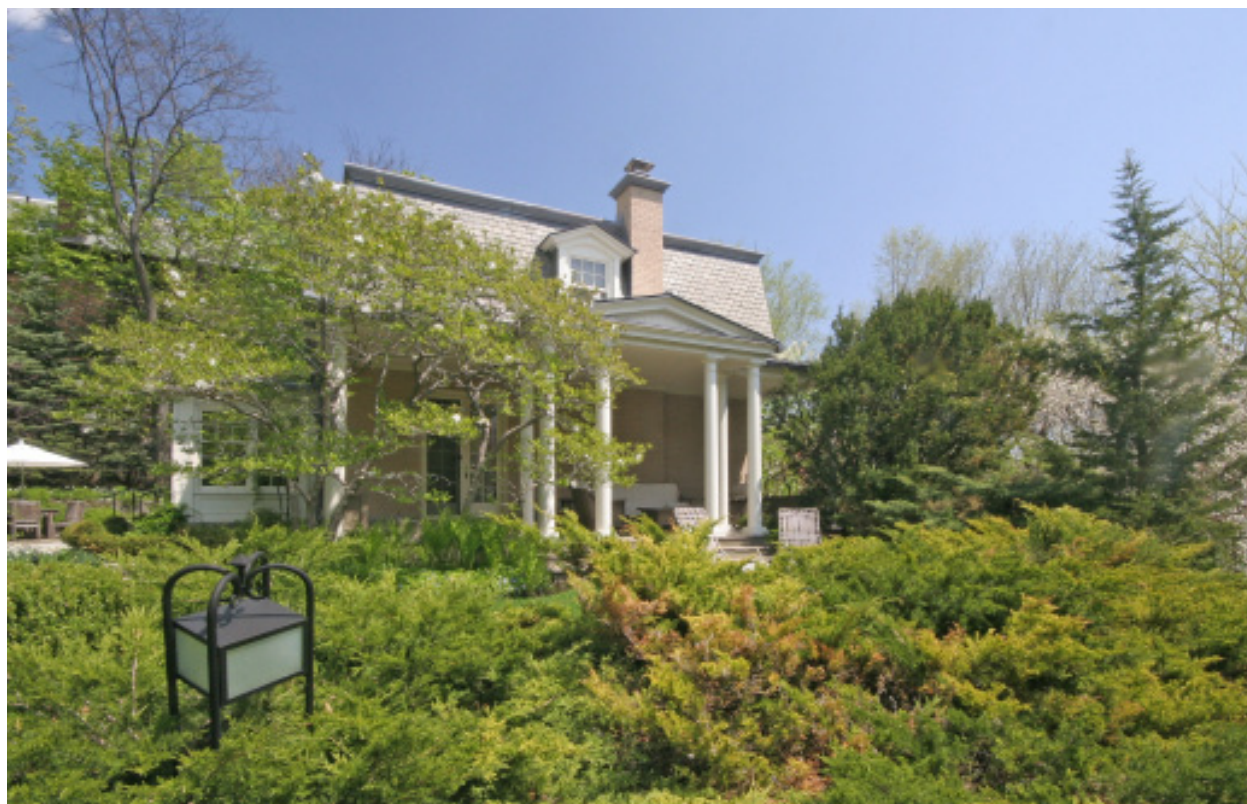
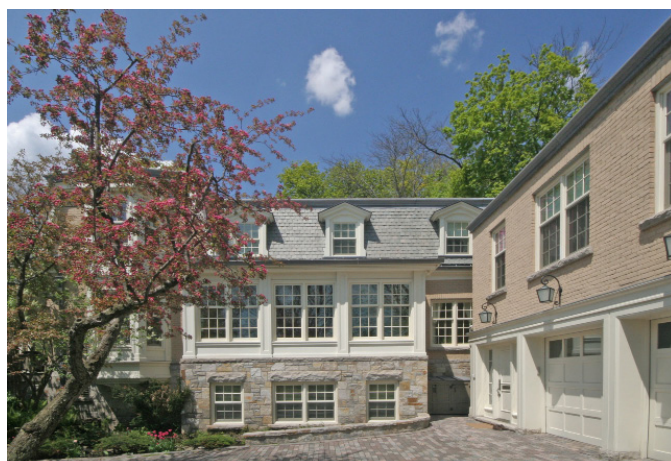
523 Argyle Road

<i>Description:</i>	A detached house where all 4 façades are of importance. However, the south (principal) and east (street) façades are more articulated and of greater architectural value. Heritage value derives from Historic Value, related to age; Urban Value related to dominant setting in large garden.
<i>Date of construction:</i>	Circa 1872-1879 ¹
<i>Persons associated with:</i>	Alex Cross or Alex Foster; Fetherstonhaugh and Durnford 1945 miscellaneous works
<i>Stylistic influences:</i>	Neo-Classical villa
<i>Materials:</i>	
<i>Cladding (HCDE):</i>	Brick; Painting is probably not original; colour selection certainly not original.
<i>Roof (HCDE):</i>	Slate Mansard
<i>Windows (HCDE):</i>	Wood
<i>Woodwork (HCDE):</i>	Porch columns, dormer enrichments
<i>Composition:</i>	A house which has been added to and modified over time. B/M Study suggests that the front entrance originally faced south and this would be in keeping with the morphology of the 19th century, where the early houses faced the south and took advantage of the river views. In keeping with vernacular architecture, the building has been modified by additions that were randomly planned. These additions have little or no heritage value and could be subject to change without loss of existing heritage value.

<i>Integrity:</i>	High
	NOTE: garden setting exceptional HCDE
	¹ Beaupré/Michaud Study gives 1872. However, the house does not appear on the Fortification Survey map of 1872. It is indicated on the Hopkins map of 1879. Therefore, a date of construction between 1872-1879 is reasonable.

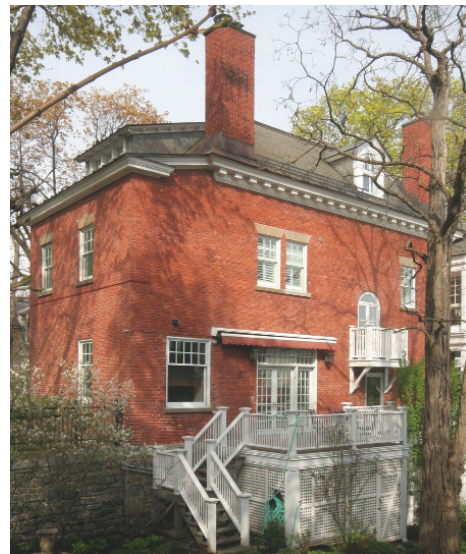
<i>Description:</i>	A detached building where all 4 façades are of importance, although east and south of primary importance. Heritage value derives from Historic Value related to its age; Artistic Value related to the architects, Neo-Georgian style, and setting in large garden.
<i>Date of construction:</i>	1901, garage: 1917, enlarged 1924, 1946
<i>Persons associated with:</i>	Lewis Skaife, original owner; MacVicar and Heriot, architects; Fetherstonhaugh, Durnford, Bolton, Chadwick, architects
<i>Stylistic influences:</i>	Neo-Georgian
<i>Materials:</i>	
<i>Cladding (HCDE):</i>	Red brick, sandstone trim
<i>Roof (HCDE):</i>	Slate
<i>Windows (HCDE):</i>	Originally Wood; currently not all are original
<i>Woodwork (HCDE):</i>	Contributes to overall variety and richness of detailing; gallery, porch, Palladian window. Cornice, etc. (NOTE: there is something curious happening on the north wing, where there is no existing cornice; however, the extension appears to be original.)

<i>Composition:</i>	In keeping with the Georgian Revival, principal façade is symmetrical; this principle is more loosely applied on the other façades.
<i>Integrity:</i>	High: A comparison with the architect's perspective demonstrates that little has changed. Even the south porch is intact, although there appear to have been modifications to the access to the garden and the exterior stairs.
	NOTE: garden setting important HCDE

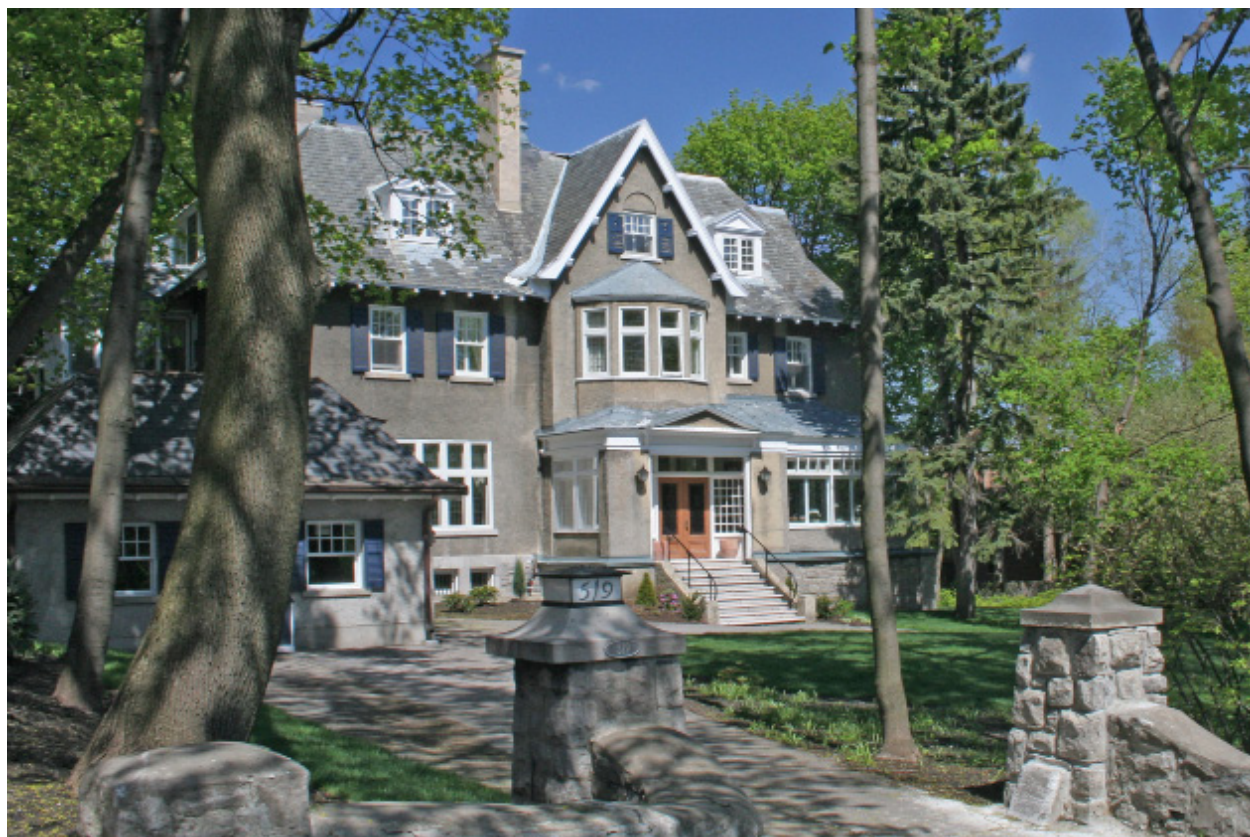
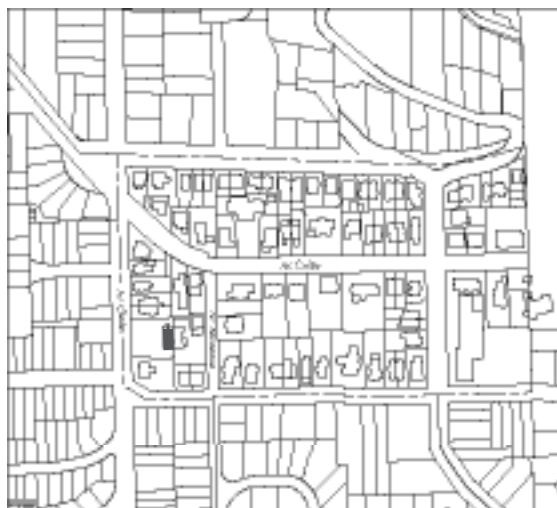
519 Clarke Avenue

<i>Description:</i>	<p>A semi-detached building where 3 façades are of importance, although north façade of lesser value.. This building shares a party wall with 504 Mountain Avenue and is the product of a single construction. Its history remains murky. The derivation of heritage value is not certain. It may be associated with its age, particularly if the two houses were originally one, as 19th c. insurance map research suggests. Its association with J.S.Archibald, a well-respected local architect, seems tenuous and insufficient to contribute significant heritage value. The only references on file to his work relate to renovations, so that it is not certain that he was the architect for the ensemble.</p>
<i>Date of construction:</i>	1927 According to B/M Study. Map research indicates that the ensemble of the Clarke and Mountain houses predates the 1920s and that the original house was probably subdivided after the First World War. The exact evolution of the property remains uncertain.

<i>Persons associated with:</i>	John Smith Archibald, architect
<i>Stylistic influences:</i>	Gothic Revival, Neo-classical, Queen Anne Revial
<i>Materials:</i>	
<i>Cladding (HCDE):</i>	Stucco over unknown substrate
<i>Roof (HCDE):</i>	Slate
<i>Windows (HCDE):</i>	Wood; not original
<i>Woodwork (HCDE):</i>	Contributes to overall variety and richness of detailing
<i>Composition:</i>	<p>The South façade, which is shared with 504 Mountain Avenue, forms a continuous composition, uninterrupted by any explicit indication of party walls. It has a row of tall windows, set in shallow arched reveals, which span from east to west, across both houses. There have been secondary additions to the façades, which mask the original form of the building, but which are not in themselves inappropriate. The building's Irregularity is an important HCDE. The date of the stucco coating is unknown. It is possible that it was applied at the time of the sub-division of the property, but there is no certainty, since there is no proof of the subdivision. Further research should be undertaken if the owner wishes to remove or alter the cladding material, to make proof of its age.</p>

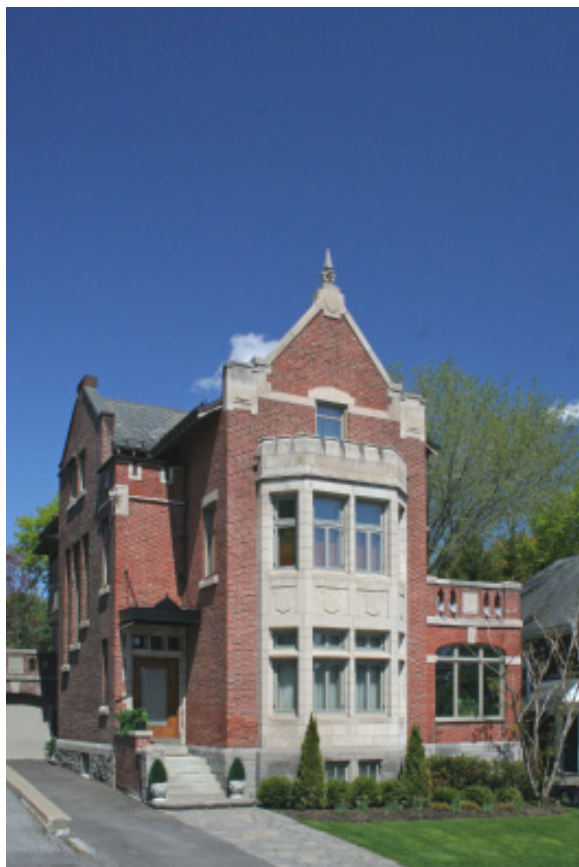
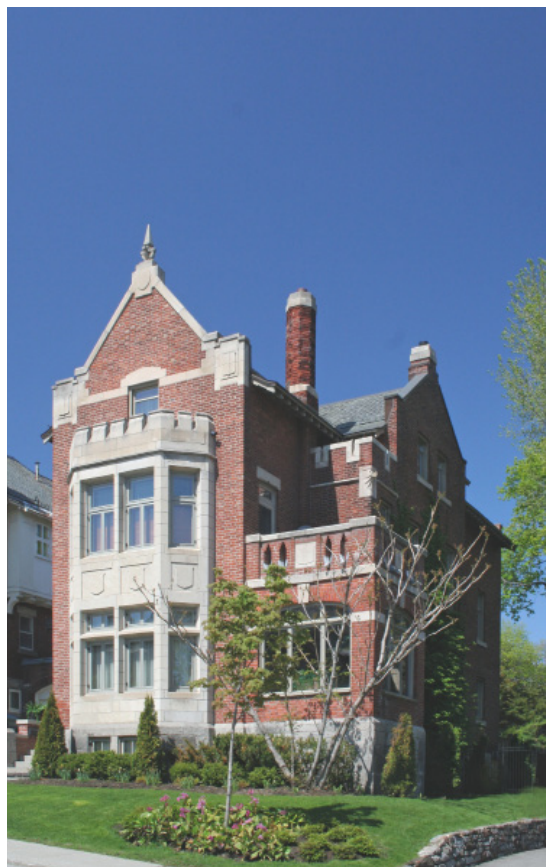
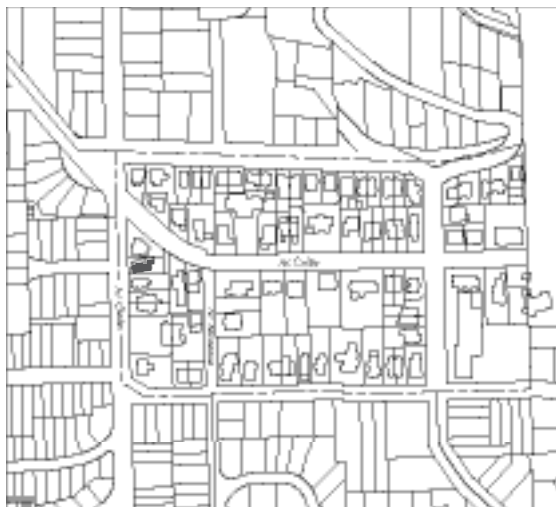
529 Clarke Avenue

<i>Description:</i>	A detached house where all 4 façades are of importance. However, the west (principal), north and south (side) façades are more articulated and of greater architectural value. Heritage value derives from Historic Value, related to age; Artistic Value related to Queen Anne Revival/Arts+Crafts style, with Picturesque massing and varied roofline.
<i>Date of construction:</i>	1907
<i>Persons associated with:</i>	James Oliver, original owner
<i>Stylistic influences:</i>	Queen Anne Revival elements/Arts+Crafts elements
<i>Materials:</i>	
<i>Cladding (HCDE):</i>	Brick with stone trim; limestone base elements
<i>Roof (HCDE):</i>	Slate
<i>Windows (HCDE):</i>	Wood; original; varied types:
<i>Woodwork (HCDE):</i>	Majority of trim in stone, woodwork minimal
<i>Composition:</i>	In keeping with the Queen Anne Revival and Arts+Crafts, all façades are non-symmetrical; these irregularities are important HCDE.

<i>Integrity:</i>	High
	NOTE: garden setting HCDE

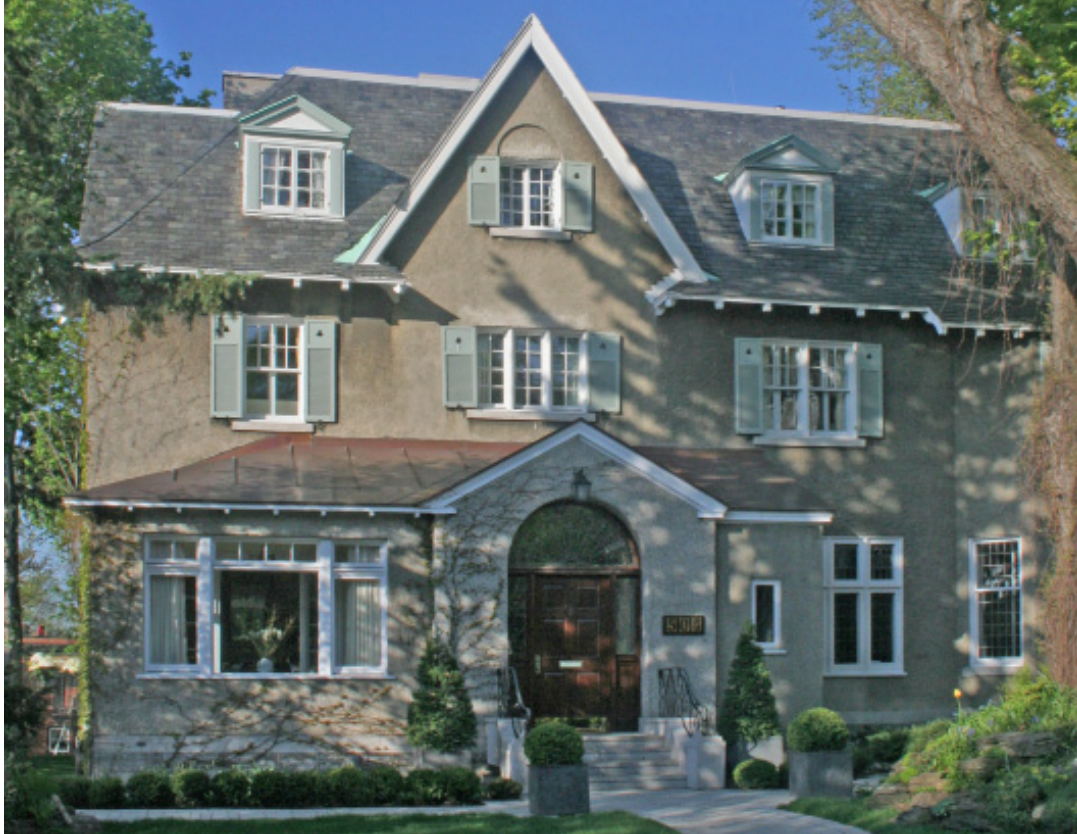
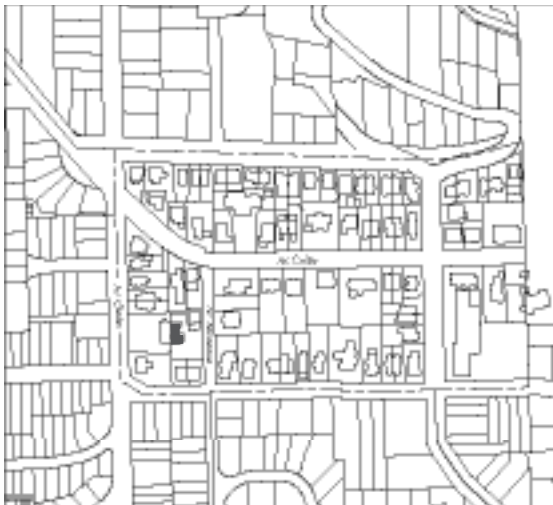
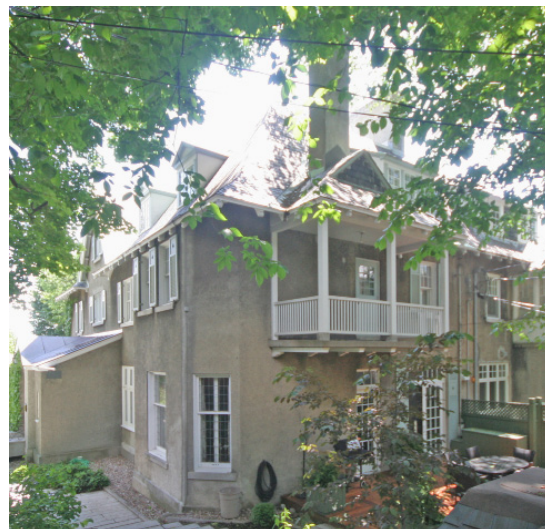
504 Mountain Avenue

<i>Description:</i>	A semi-detached building where 3 façades are of importance. This building shares a party wall with 519 Clarke Avenue and is the product of a single construction. Its history remains murky. The derivation of heritage value is not certain. It may be associated with its age, particularly if the two houses were originally one, as map research suggests. Its association with J.S.Archibald, a well-respected local architect, seems tenuous and insufficient to contribute significant heritage value. The only references on file to his work relate to renovations, so that it is not certain that he was the architect for the ensemble. If the ensemble was originally a single property, as the 19th century maps suggest, then the stable on Mountain Avenue, which is now a separate property, was part of the estate.
<i>Date of construction:</i>	1927 According to B/M Study. Map research indicates that the ensemble of the Clarke and Mountain houses predates the 1920s and that the original house was probably subdivided after the First World War. The exact evolution of the property remains uncertain.

<i>Persons associated with:</i>	John Smith Archibald, architect
<i>Stylistic influences:</i>	Cottage
<i>Materials:</i>	
<i>Cladding (HCDE):</i>	Stucco over unknown substrate
<i>Roof (HCDE):</i>	Slate
<i>Windows (HCDE):</i>	Wood; not original
<i>Woodwork (HCDE):</i>	Contributes to overall variety and richness of detailing
<i>Composition:</i>	The South façade, which is shared with 519 Clarke Avenue, forms a continuous composition, uninterrupted by any explicit indication of party walls. It has a row of tall windows, set in shallow arched reveals, which span from east to west, across both houses. There have been secondary additions to the façades, which mask the original form of the building, but which are not in themselves inappropriate. The irregularity of this buildings is an important HCDE. The date of the stucco coating is unknown. It is possible that it was applied at the time of the sub-division of the property, but there is no certainty, since there is no proof of the subdivision. Further research should be undertaken if the owner wishes to remove or alter the cladding material, to make proof of its age.

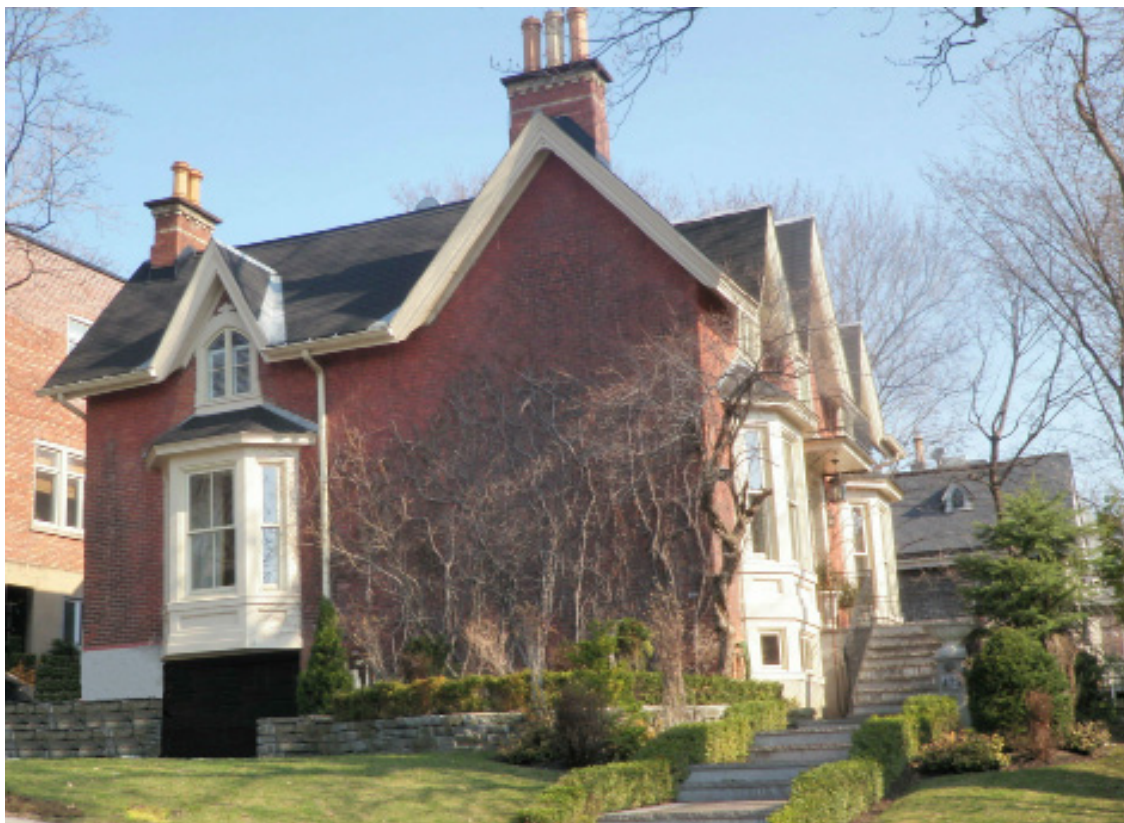
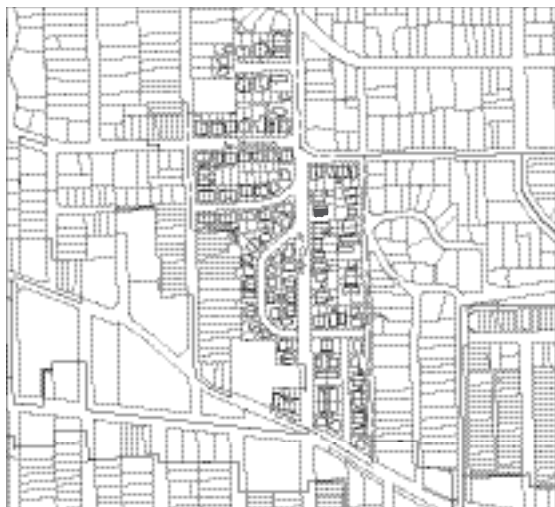
473 Clarke Avenue

<i>Description:</i>	A detached building where 3 façades of main pavilion are important; rear façade of main pavilion and those of servants' wing of lesser importance. Heritage value derives from Historic Value related to age; and Artistic Value, related to architecture; and Urban Value related to remarkable garden setting.
<i>Date of construction:</i>	Circa 1885
<i>Persons associated with:</i>	Jeffrey Penfold (owner)
<i>Stylistic influences:</i>	Neo-Gothic cottage
<i>Materials:</i>	
<i>Cladding (HCDE):</i>	Red brick
<i>Roof (HCDE):</i>	Not original, roof material originally slate.
<i>Windows (HCDE):</i>	Wood, original
<i>Woodwork (HCDE):</i>	Window hoods, bay windows
<i>Composition:</i>	The main body of the house is treated as a pavilion. The servants' wing is contained in a wing which is recessed from the main pavilion and is shorter in height. It is therefore subservient to the pavilion. The composition of the pavilion is unusual: the front façade is symmetrical, in a manner not consistent with the Picturesque principles of the Gothic revival. The other façades are more loosely disposed. In keeping with earliest houses built on slopes in Westmount, the principal façade addresses the south and the views towards the river, rather than the street. The garage is a modern and unfortunate intervention, which could be modified/eliminated.

<i>Integrity:</i>	High for the main pavilion. The servants' wing is to be modified, with an extension to the east.
	NOTE: chimneys HCDE

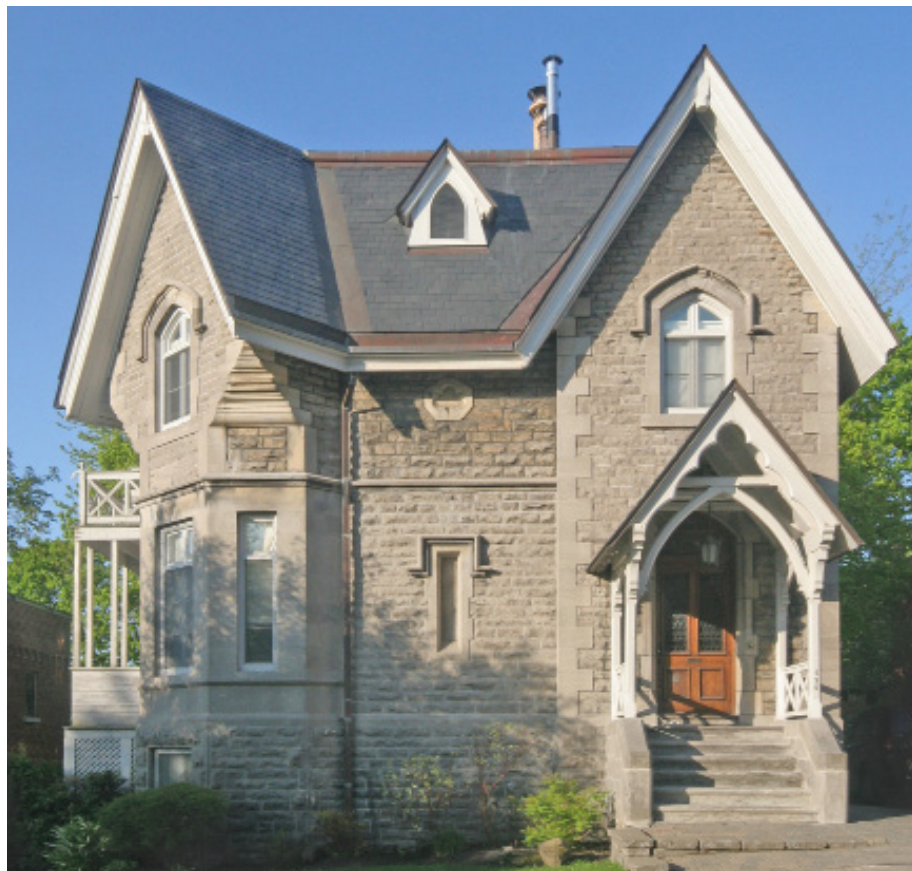
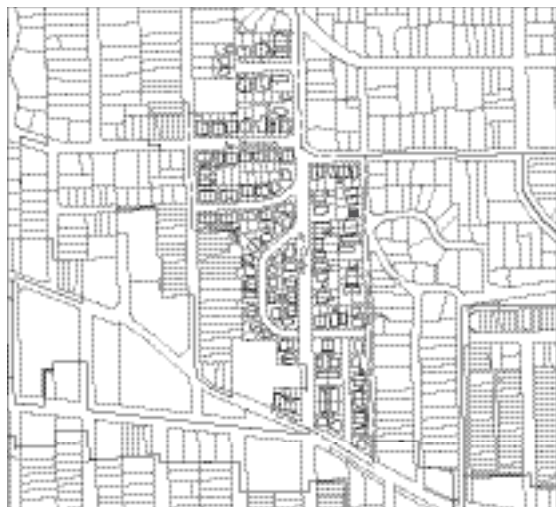
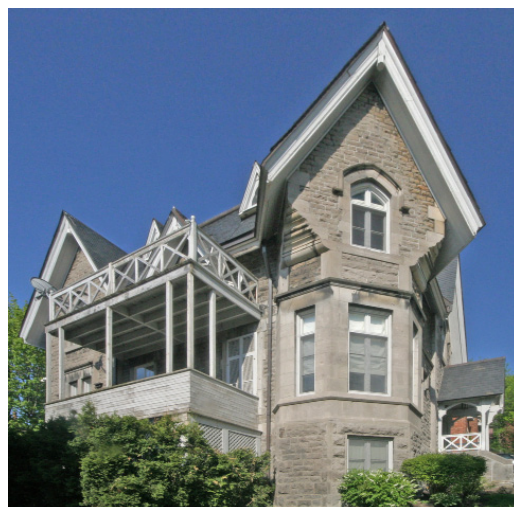
490 Mountain Avenue

<i>Description:</i>	A detached building where all 4 façades are of importance. However, the north façade is very much a secondary façade, even though it has a continuity of materials. Heritage value derives from Historic Value, related to age, Urban Value, related to dominant setting on Mountain Avenue and its garden; Artistic Value related to Gothic Revival style with Picturesque massing and varied roofline.
<i>Date of construction:</i>	1868
<i>Persons associated with:</i>	Daniel Wilson, original owner, contractor, Westmount Councillor
<i>Stylistic influences:</i>	Gothic Revival
<i>Materials:</i>	
<i>Cladding (HCDE):</i>	Rough-hewn coursed limestone with ashlar trim
<i>Roof (HCDE):</i>	Slate
<i>Windows (HCDE):</i>	Wood; original
<i>Woodwork (HCDE):</i>	Contributes to overall variety and richness of detailing; gallery, dormer enrichments, entry porch, etc.
<i>Composition:</i>	In keeping with the Gothic Revival, all facades are non-symmetrical. These irregularities are important HCDE. Characteristic of early houses in Westmount, the house is oriented towards the south and the views of the river. Therefore, the side garden is an important HCDE of the setting.

<i>Integrity:</i>	High, although the woodwork, particularly on the side porch has been modified.
	NOTE: garden setting exceptional HCDE

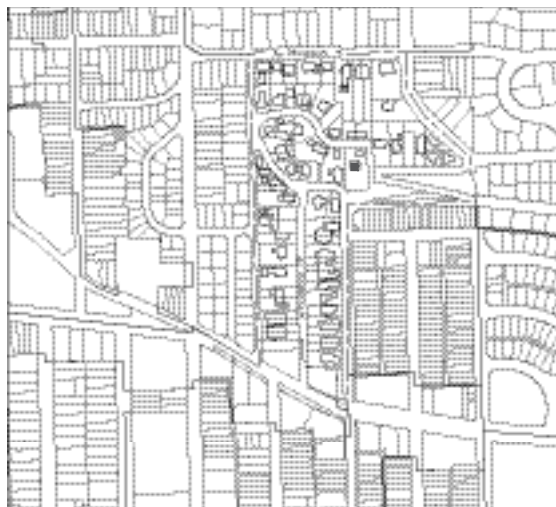
<i>Description:</i>	A Detached house where all 4 façades are of importance. However, the south (principal) and east (street) façades are more articulated and of greater architectural value. Heritage Value derives from age; consistency of style; dominant setting; and large garden.
<i>Date of construction:</i>	Circa 1892
<i>Persons associated with:</i>	Built by James Robert Reekie as dowery house for his daughter Elizabeth Reekie Ward; Owned and restored by Rosanne Moss, architect
<i>Stylistic influences:</i>	Queen Anne Revival
<i>Materials:</i>	
<i>Cladding (HCDE):</i>	Wood clapboard/wood shingle on upper storey
<i>Roof (HCDE):</i>	Asphalt shingles (originally slate)
<i>Windows (HCDE):</i>	Wood; not original; varied types: majority double hung, 1 oeil de boeuf; occasional casements
<i>Woodwork (HCDE):</i>	Contributes to overall variety and richness of detailing; gallery, porch, string courses between storeys, ornamentation of turrets, windows, etc.

<i>Composition:</i>	In keeping with the Queen Anne Revival, all façades are non-symmetrical. These irregularities are important HCDE. Woodwork details, with exception of porch – although sympathetic, is almost entirely from the 1980s. Additionally, the garden setting is of importance.
<i>Integrity:</i>	High, although much restoration/rehabilitation work done from 1983-2007; porch woodwork not original, as noted above.

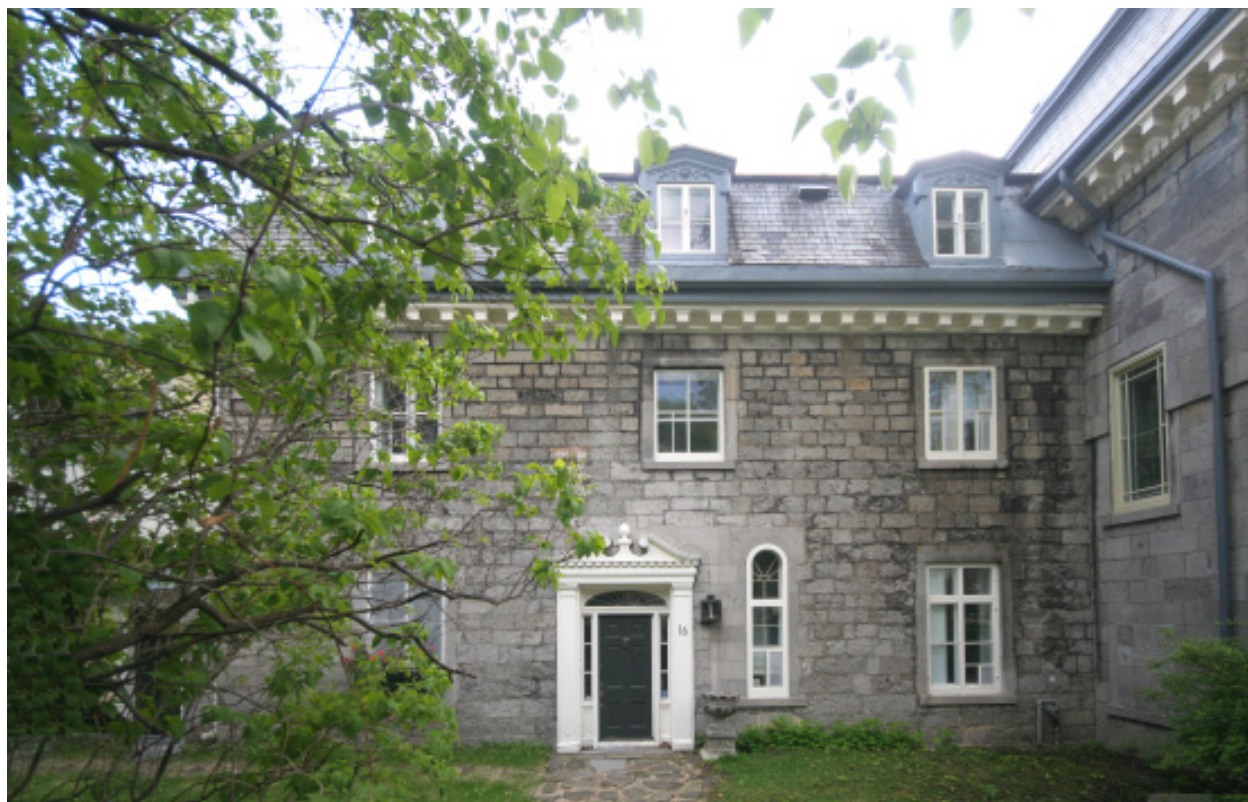
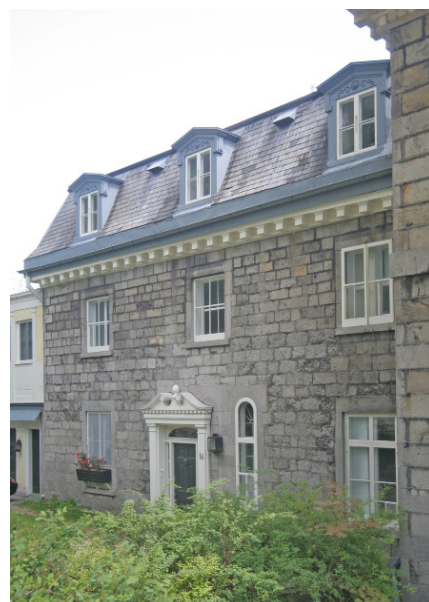
<i>Description:</i>	This Semi-detached house is intrinsically linked to 18 Severn Avenue. According to notarial evidence ¹ 18 Severn Avenue, the original “Rosemount”, was divided into two dwellings in 1892 by severing its eastern wing, which with minor modifications, became 16 Severn Avenue. Visual evidence would suggest that 16 Severn Avenue was once either a servants’ wing or annex to 18 Severn Avenue. The street façade and garden façades are deemed to be of importance. The garage to the east was modified in 2006, with the addition of a second storey. It is clear from photographic evidence that the garage, like the street façade have been altered several times. Heritage value derives from Historic Value, related to age and associations with John Young and intrinsic relationship to 18 Severn Avenue and Aesthetic Value related to relatively intact condition of stonework, windows and roof and woodwork.

<i>Date of construction:</i>	1847-1861 ² , or 1859-1862 ³ , Dates of Modifications on record: 1943
<i>Persons associated with:</i>	John Young, 1811-1878
<i>Stylistic influences:</i>	Neo-Classical, Picturesque Villa
<i>Materials:</i>	
<i>Cladding (HCDE):</i>	Montreal grey limestone, coursed with emphasized joints; ashlar trim
<i>Roof (HCDE):</i>	Slate mansards, with pronounced cornice. Date from c.1880, according to B/M, although there is little documentary evidence to support this assertion.
<i>Windows (HCDE):</i>	Wood; original; Dormer enrichments
<i>Woodwork (HCDE):</i>	Entrance portico with broken pediment (post 1920s) has less value
<i>Composition:</i>	Given that this residence was built as a secondary wing to 18 Severn, it is difficult to speak of a “composition”, in that it was never intended to be a stand alone building. In keeping with neo-classical principles, all façades are symmetrical. The placement of the front door —off axis— is a clear indication that it was added at a later date. A photo, taken in the 1920s, shows an entry porch whose form traces the scarring of the masonry which is still visible. The fact that the ground floor is virtually flush with the exterior grade is another indication that it was once a secondary wing to its more imposing neighbour.

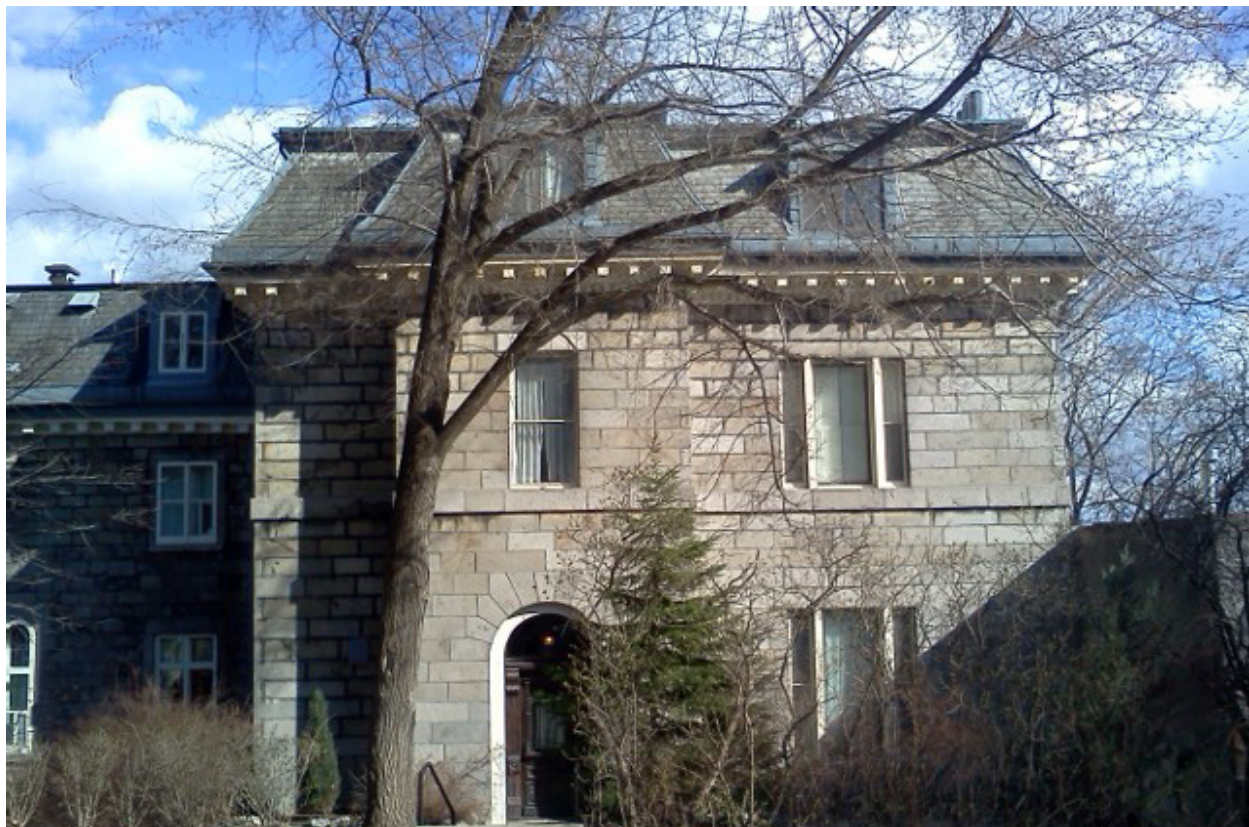
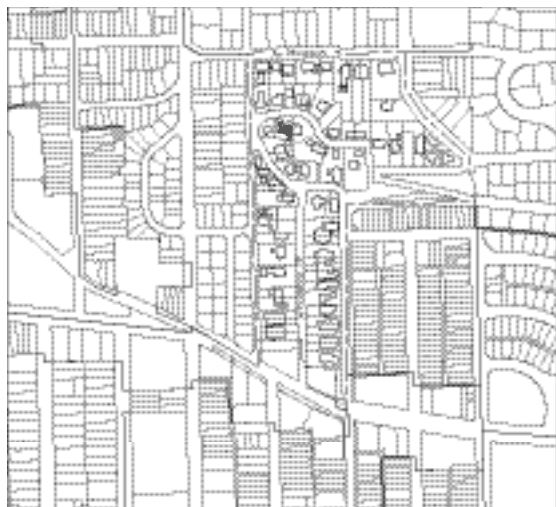
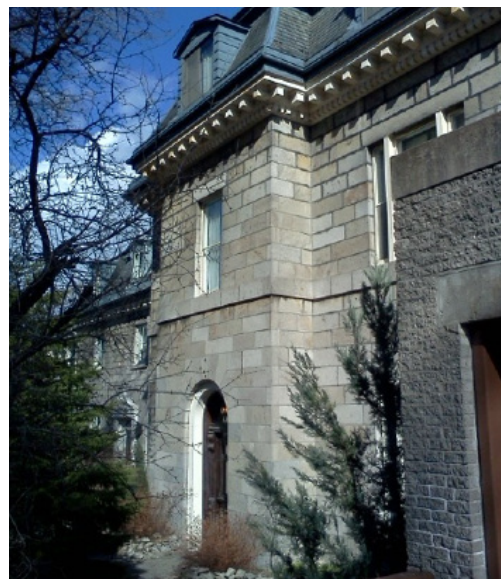
18 Severn Avenue

<i>Description:</i>	This Semi-detached house is intrinsically linked to 16 Severn Avenue. According to notarial evidence ¹ 18 Severn Avenue, the original “Rosemount”, was divided into two dwellings in 1892 by severing its eastern wing, which with minor modifications, became 16 Severn Avenue. The street, garden and west facades are deemed to be of importance. Heritage value derives from Historic Value, related to age and associations with John Young and intrinsic relationship to 16 Severn Avenue; and Aesthetic Value related to exceptional quality of stonework, windows and roof and woodwork.
<i>Date of construction:</i>	1847-61 ² or 1859-1862 ³ , Dates of Modifications: 1953-61-67-76-81
<i>Persons associated with:</i>	John Young, 1811-1878
<i>Stylistic influences:</i>	Neo-Classical, Picturesque villa
<i>Materials:</i>	
<i>Cladding (HCDE):</i>	Montreal grey limestone, coursed with emphasized joints; ashlar trim

<i>Roof (HCDE):</i>	Slate mansards, with pronounced cornice. Date from c.1880, according to B/M, although there is little documentary evidence to support this assertion.
<i>Windows (HCDE):</i>	Wood; original; Dormer enrichments
<i>Composition:</i>	The composition is picturesque, according to the principles of AJ Downing; the vertical thrust of the entry tower is balanced by the horizontality of the servants’ wing (now 16 Severn Avenue).
<i>Integrity:</i>	High

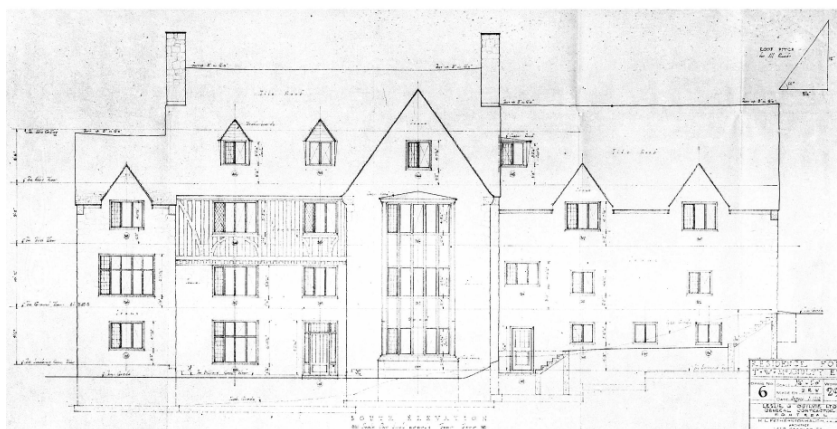
South Elevation, 1929

Description: A detached building where all 4 façades are of importance. Heritage value derives from Historic Value related to age; and Artistic Value, related to architecture and architects.

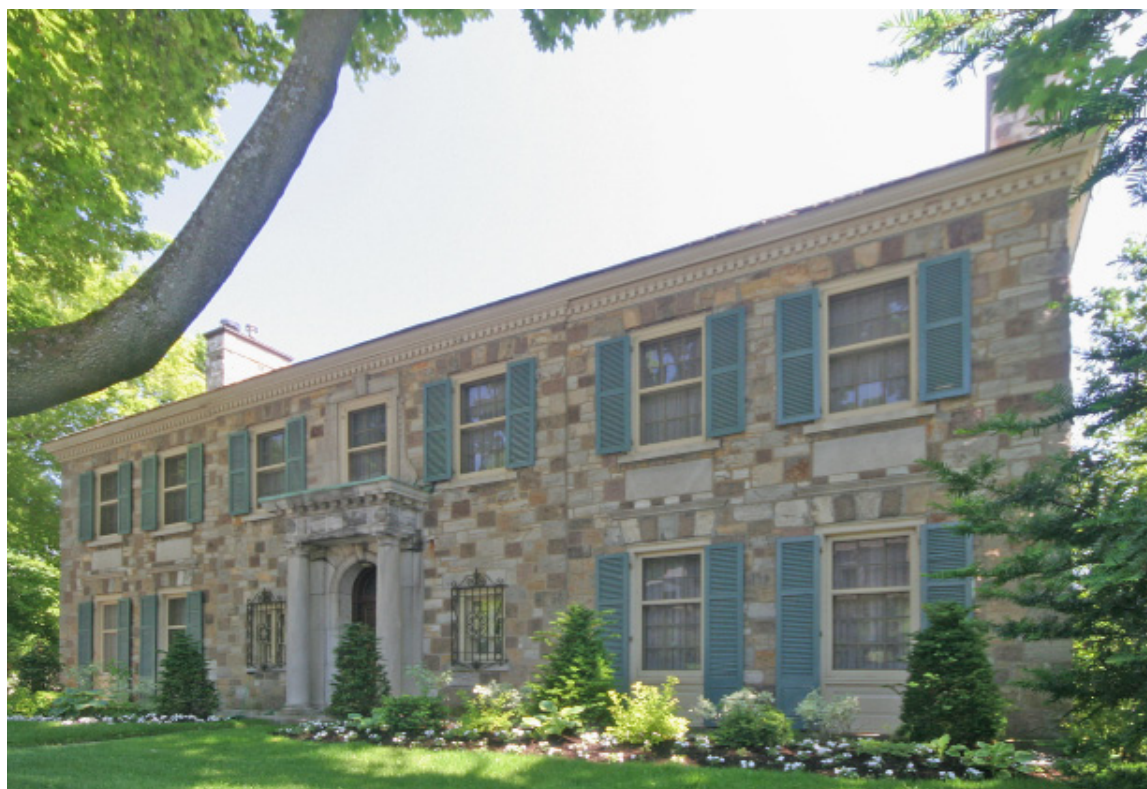
3122 Daulac Avenue

<i>Description:</i>	A detached building where all 4 façades are of importance. Heritage value derives from Historic Value related to age; and Artistic Value, related to architecture and architects; Associative Value related to the visit of the Queen Mother in the 1980s.
<i>Date of construction:</i>	1929-30
<i>Persons associated with:</i>	James Edmund Dodds (owner); H.L.Fetherstonhaugh, architect
<i>Stylistic influences:</i>	Neo-Classical Georgian villa
<i>Materials:</i>	
<i>Cladding (HCDE):</i>	Limestone fieldstone with ashlar trim
<i>Roof (HCDE):</i>	Slate
<i>Windows (HCDE):</i>	Wood, original
<i>Composition:</i>	Symmetry is an essential HCDE. Although there are no dormers, their addition could be possible.
<i>Integrity:</i>	High; it appears that the garage wing is original to the house.
	NOTE: chimneys HCDE

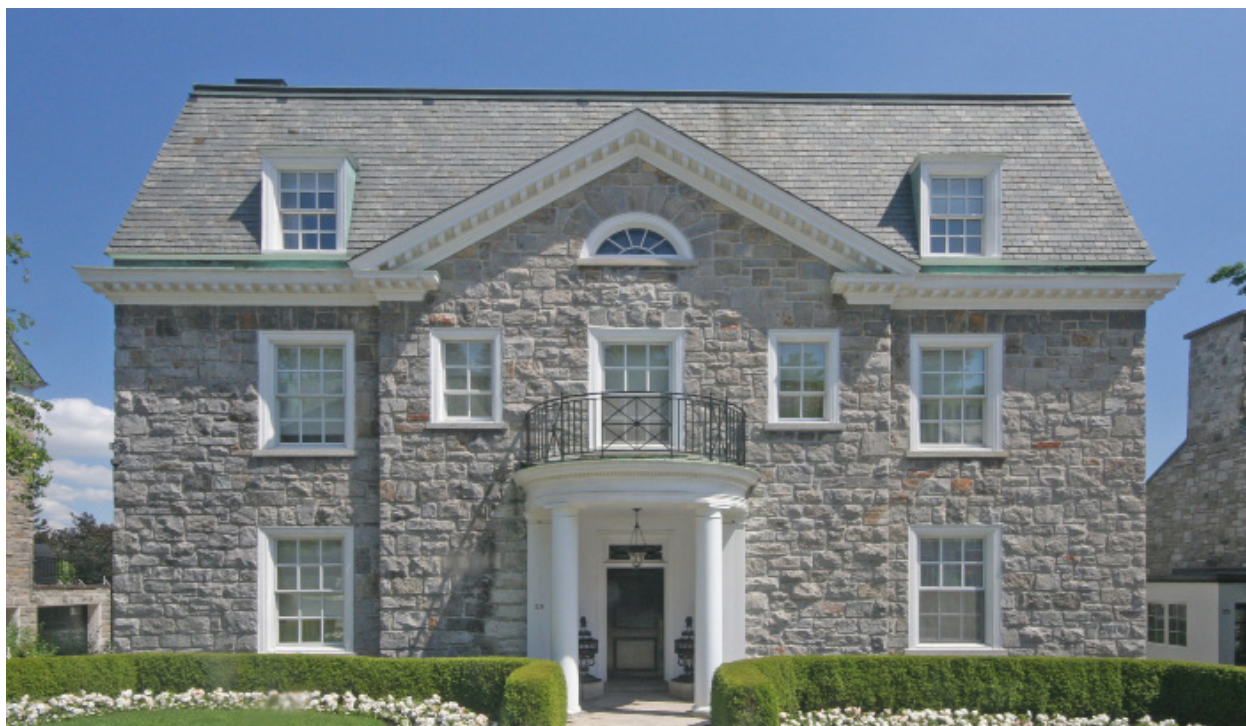
29 Ramezay Road

Description: A detached building where all 4 façades are of importance. Heritage value derives from Historic Value related to age; and Artistic Value, related to architecture and architects, and Urban Value related to remarkable garden setting.

Cladding (HCDE): Limestone fieldstone

Roof (HCDE): Mansard in slate

Windows (HCDE): Wood, original

Woodwork (HCDE): Window hoods, cornice and porch Ironwork of balcony railing (HCDE)

Composition: The composition is rigidly symmetrical. Symmetry is a HCDE of the building.

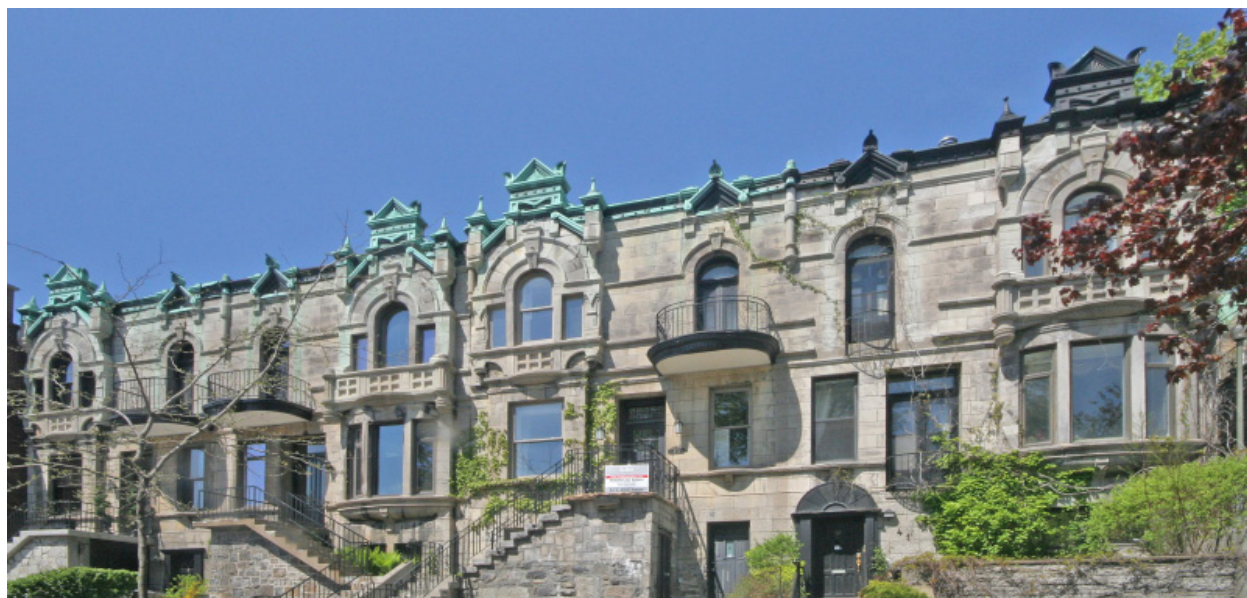
41 Holton Avenue

<i>Description:</i>	This building is part of a Repetitive Ensemble: only the front façade is of importance. Heritage value derives from Historic Value related to age, Artistic Value related to Renaissance Revival detailing, general integrity of ensemble.
<i>Date of construction:</i>	1903
<i>Persons associated with:</i>	A. Paquette (builder and owner)
<i>Stylistic influences:</i>	Renaissance Revival
<i>Materials:</i>	
<i>Cladding (HCDE):</i>	Limestone
<i>Roof (HCDE):</i>	Flat
<i>Windows (HCDE):</i>	Wood; not original
<i>Woodwork (HCDE):</i>	There is little woodwork on buildings; ornamentation in stone or sheet metal.
<i>Composition:</i>	The ensemble is composed of a duplex unit, containing two houses, which is repeated once, to provide a streetscape of 4 houses. The duplex unit is symmetrical about the middle, with centralized doors, flanked by tower-like elements, each of which is crowned by a sheet metal decorative element. The siting of the house is unusual; the building line is quite set back from the street, allowing for substantial stairs to provide access to a front door set high in the façade.

<i>Integrity:</i>	<p>The integrity of 41 Holton has been compromised by the relocation of the front door closer to grade and the conversion of the original door into a window. As well, the upper balcony has been altered.</p> <p>NOTE: The rear façade is of much less significance and integrity, and could be subject to greater change. However, because it is visible from Mount Pleasant Avenue, changes must remain respectful and complement the quality and integrity of the main façade.</p>
