City of Westmount

Heritage Character Defining Elements:
Category 1★ Buildings

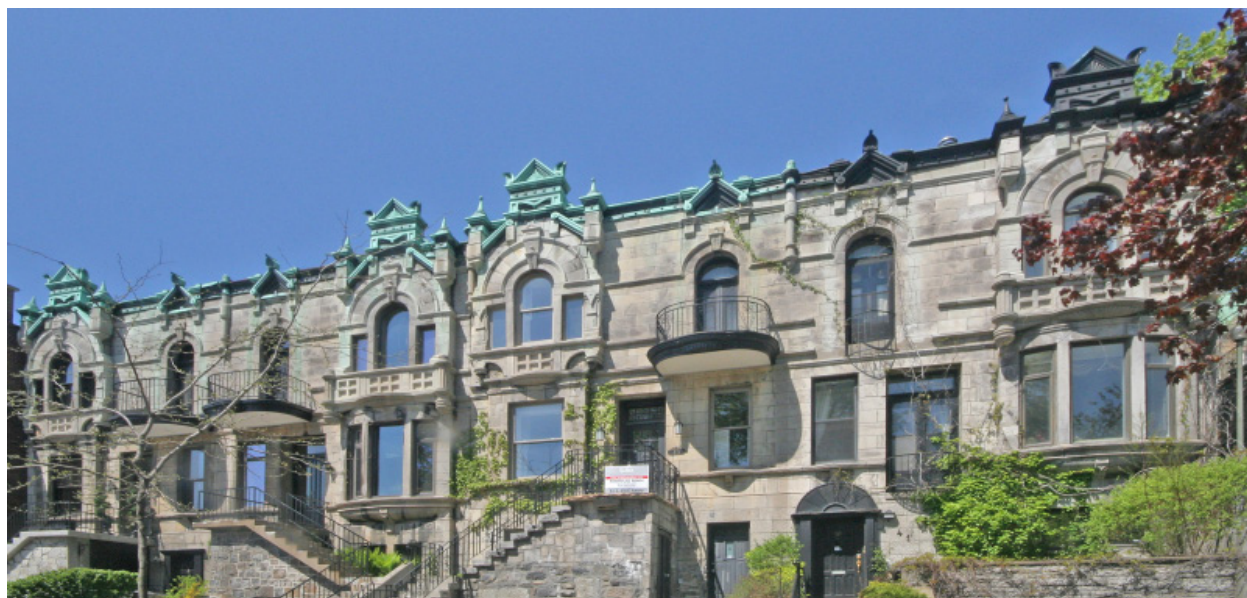
43 Holton Avenue

<i>Description:</i>	This building is part of a Repetitive Ensemble: only the front façade is of importance. Heritage value derives from Historic Value related to age, Artistic Value related to Renaissance Revival detailing, general integrity of ensemble.
<i>Date of construction:</i>	1903
<i>Persons associated with:</i>	A. Paquette (builder and owner); B. Anderson, architect and owner, c.1995
<i>Stylistic influences:</i>	Renaissance Revival
<i>Materials:</i>	
<i>Cladding (HCDE):</i>	Limestone
<i>Roof (HCDE):</i>	Flat
<i>Windows (HCDE):</i>	Wood; not original
<i>Woodwork (HCDE):</i>	There is little woodwork on buildings; ornamentation in stone or sheet metal.
<i>Composition:</i>	The ensemble is composed of a duplex unit, containing two houses, which is repeated once, to provide a streetscape of 4 houses. The duplex unit is symmetrical about the middle, with centralized doors, flanked by tower-like elements, each of which is crowned by a sheet metal decorative element. The siting of the house is unusual; the building line is quite set back from the street, allowing for substantial stairs to provide access to a front door set high in the façade.

<i>Integrity:</i>	High NOTE: The rear façade is of much less significance and integrity, and could be subject to greater change. However, because it is visible from Mount Pleasant Avenue, changes must remain respectful and complement the quality and integrity of the main façade.

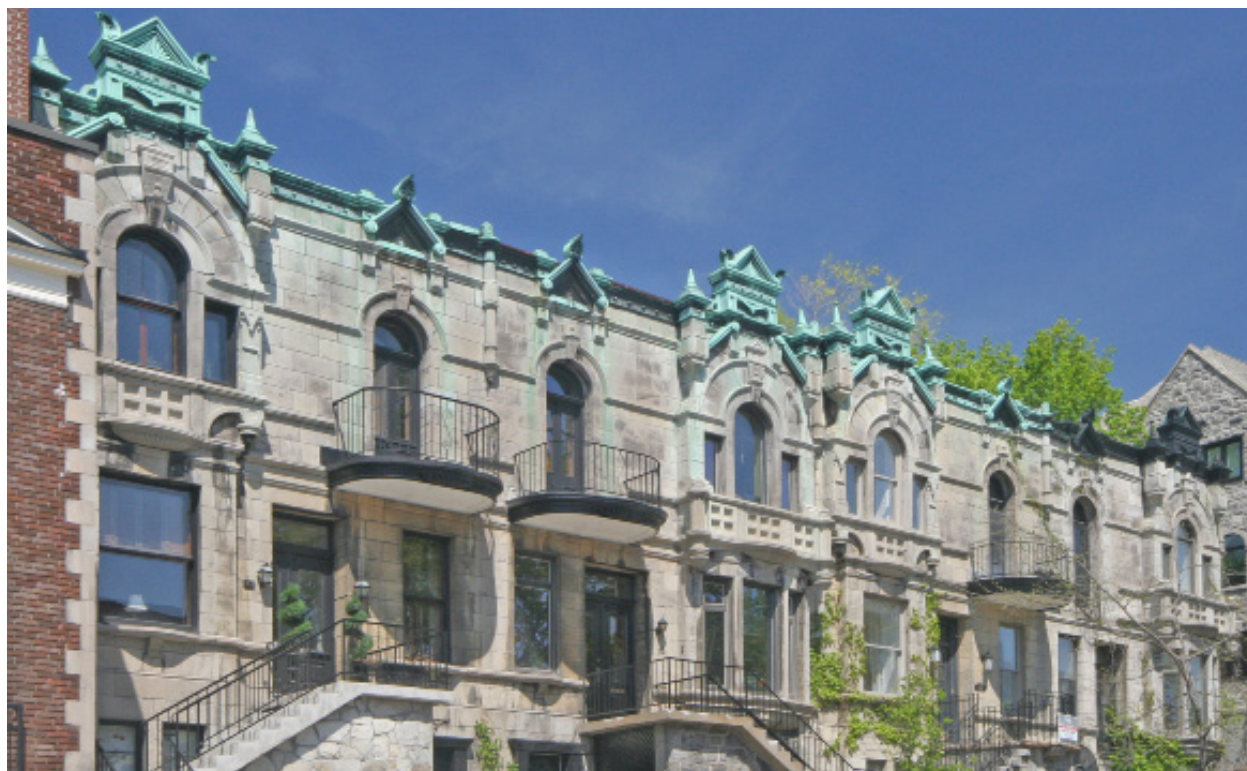
45 Holton Avenue

<i>Description:</i>	This building is part of a Repetitive Ensemble: only the front façade is of importance. Heritage value derives from Historic Value related to age, Artistic Value related to Renaissance Revival detailing, general integrity of ensemble.
<i>Date of construction:</i>	1903
<i>Persons associated with:</i>	A. Paquette (builder and owner); B. Anderson, architect and owner, c.1995
<i>Stylistic influences:</i>	Renaissance Revival
<i>Materials:</i>	
<i>Cladding (HCDE):</i>	Limestone
<i>Roof (HCDE):</i>	Flat
<i>Windows (HCDE):</i>	Wood; not original
<i>Woodwork (HCDE):</i>	There is little woodwork on buildings; ornamentation in stone or sheet metal.
<i>Composition:</i>	The ensemble is composed of a duplex unit, containing two houses, which is repeated once, to provide a streetscape of 4 houses. The duplex unit is symmetrical about the middle, with centralized doors, flanked by tower-like elements, each of which is crowned by a sheet metal decorative element. The siting of the house is unusual; the building line is quite set back from the street, originally allowing for substantial stairs to provide access to a front door set high in the façade. Probably, the stairs have been reworked to allow for a parking pad.

<i>Integrity:</i>	High NOTE: The rear façade is of much less significance and integrity, and could be subject to greater change. However, because it is visible from Mount Pleasant Avenue, changes must remain respectful and complement the quality and integrity of the main façade.

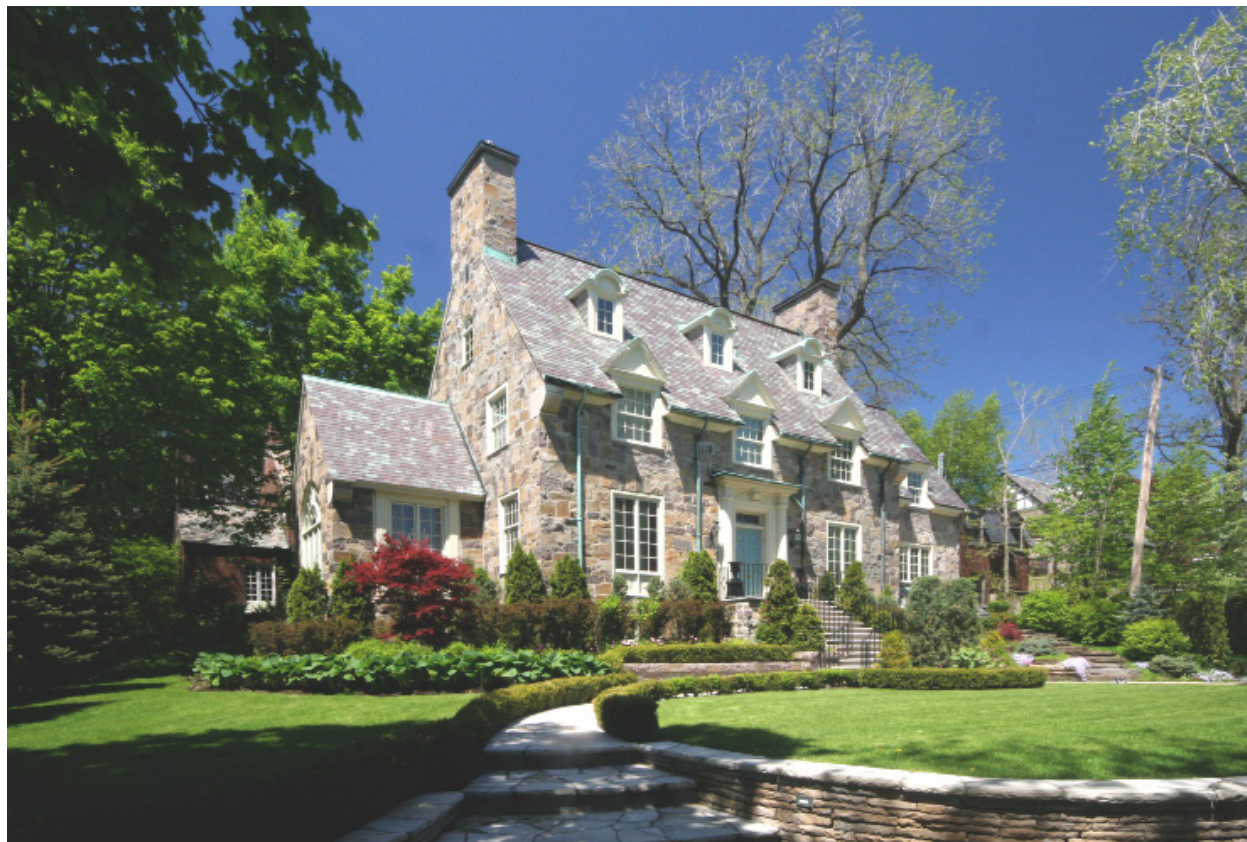
49 Forden Avenue

<i>Description:</i>	A detached building where all 4 façade are of importance. Heritage value derives from Historic Value related to age; and Artistic Value, related to architecture and architects, and Urban Value related to remarkable garden setting.
<i>Date of construction:</i>	1928, 1968
<i>Persons associated with:</i>	J.B. Fellowes (owner), Shorey and Ritchie, architects
<i>Stylistic influences:</i>	“Canadien” farmhouse, Neo-Georgian
<i>Materials:</i>	
<i>Cladding (HCDE):</i>	Limestone
<i>Roof (HCDE):</i>	Slate
<i>Windows (HCDE):</i>	Wood, original
<i>Woodwork (HCDE):</i>	Dormer hoods, portico
<i>Composition:</i>	The composition is generally symmetrical, for the main pavilion; there is a secondary wing, which should remain subservient to the main pavilion, so as not to disturb the original composition.
<i>Integrity:</i>	High

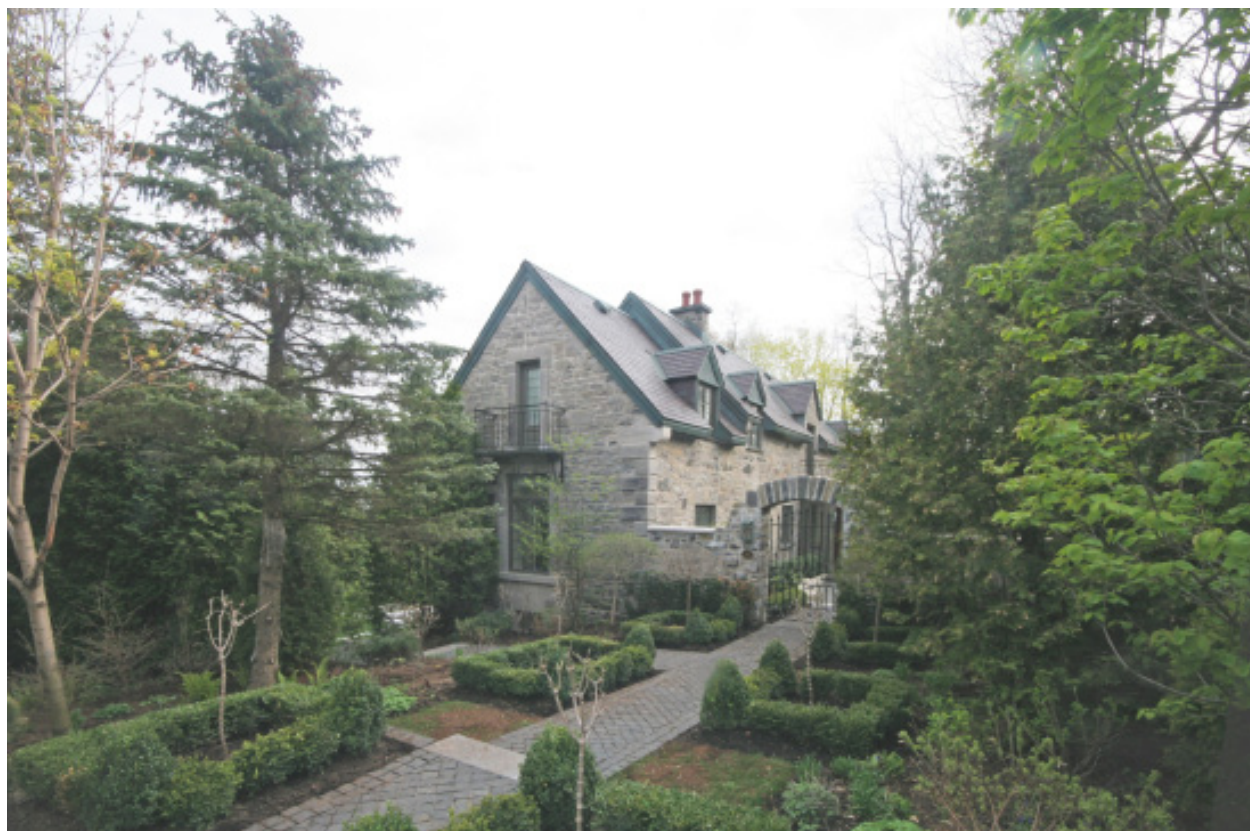
<i>Description:</i>	A detached building where all 4 façades are of importance. Heritage value derives from Historic Value related to age; and Artistic Value, related to architecture and architects, and Urban Value related to remarkable garden setting.
<i>Date of construction:</i>	1928 ¹ ; southwest wing : 1949
<i>Persons associated with:</i>	Sumner Davenport, architect and owner
<i>Stylistic influences:</i>	“Cotswald cottage”
<i>Materials:</i>	
<i>Cladding (HCDE):</i>	Limestone fieldstone
<i>Roof (HCDE):</i>	Mansard in slate
<i>Windows (HCDE):</i>	Steel, non-original
<i>Composition:</i>	The composition is non-symmetrical, in keeping with the English picturesque. However, there is a certain formality to the composition of the front façade, not maintained on the other façades.
<i>Integrity:</i>	Compromised by a series of recent interventions.

¹ There is some confusion about the history of 50 Forden Crescent. The Beaupré-Michaud Study (1987) stated that 50 Forden Crescent was originally the stables on the estate of “Forden”. The main house, which was built about 1826, was demolished in the 1950s. Beaupré-Michaud believed that 50 Forden Crescent was equally old and recommended that it be designated a Category 1* building. Recent research by Bruce Anderson, Architect has demonstrated conclusively that 50 Forden Crescent was the original barn and was demolished in its entirety about 1929. , Sumner Davenport, architect incorporated elements, including wooden beams and masonry, into the building, which he designed as his own residence. (See “A Stone Barn is Transformed”, *Canadian Homes and Gardens*, Volume VI, Number 1, January 1929). Prof. Anderson further suggests that the only wall which is original to the 19th century is the east gable wall. All this information has been incorporated into this document.

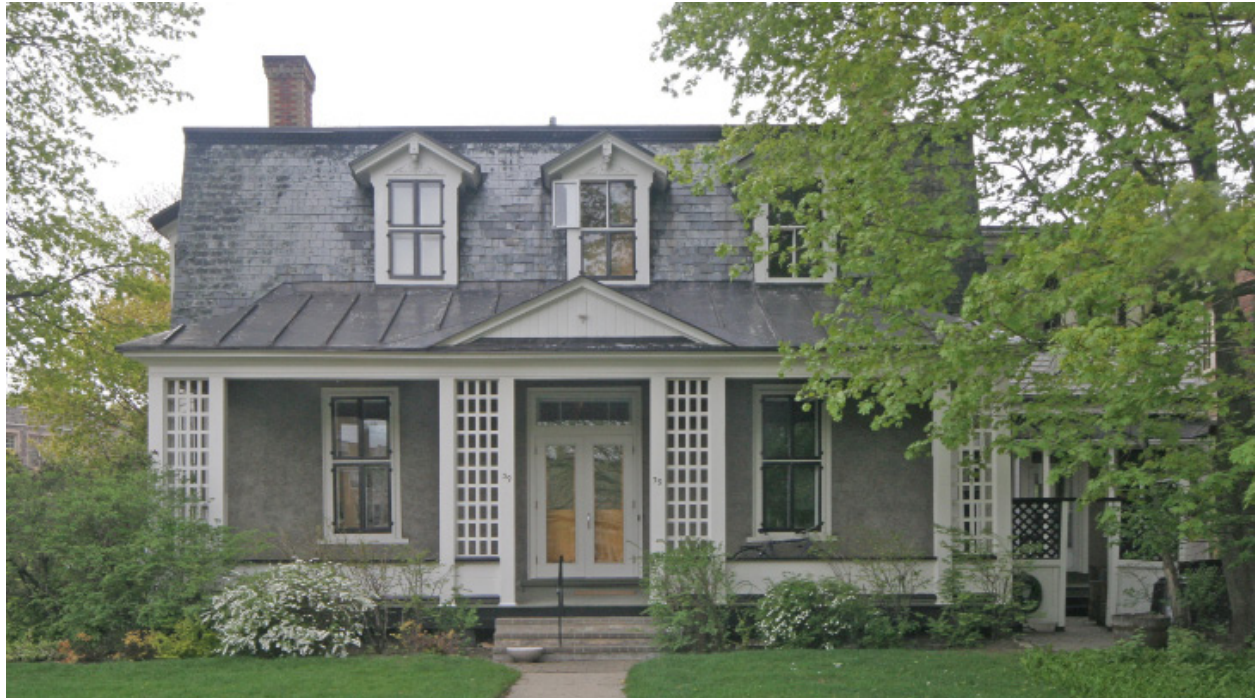
39 Cote-Saint Antoine Road

<i>Description:</i>	A semi-detached building where the South (principal) and West façades are of importance. Heritage value derives from Historic Value related to age.
<i>Date of construction:</i>	18th century
<i>Persons associated with:</i>	Decary family; Maxwell Brothers (attribution)
<i>Stylistic influences:</i>	“Canadien” farmhouse (vernacular)
<i>Materials:</i>	
<i>Cladding (HCDE):</i>	Limestone fieldstone covered in stucco
<i>Roof (HCDE):</i>	Mansard in slate: Roof is not original, but probably mid-19th century
<i>Windows (HCDE):</i>	Wood, original
<i>Woodwork (HCDE):</i>	Including gallery
<i>Composition:</i>	Building now has central pavilion with wing. Central pavilion is symmetrical about the entrance door. The wing, housing the original summer kitchen, is of lesser value and could be subject to change.
<i>Integrity:</i>	High, in an evolutionary sense that is generally associated with vernacular architecture

NOTE: chimneys HCDE

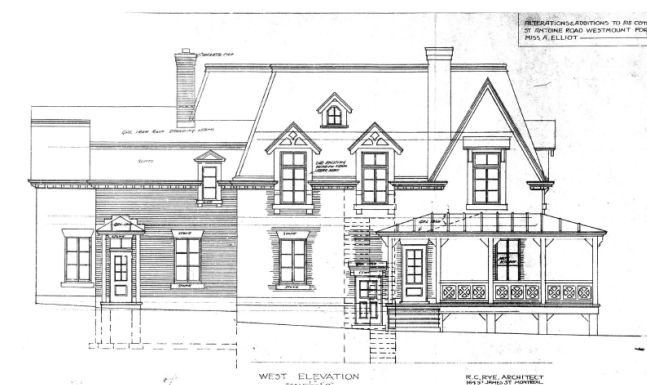
West Elevation, 1919

Description: A detached building where all 4 façades are of importance. Heritage value derives from Historic Value related to age; and Artistic Value, related to architecture, and Urban Value related to remarkable garden setting.

Roof (HCDE): Polychromed slate Mansard with cornice (Probably cresting missing)

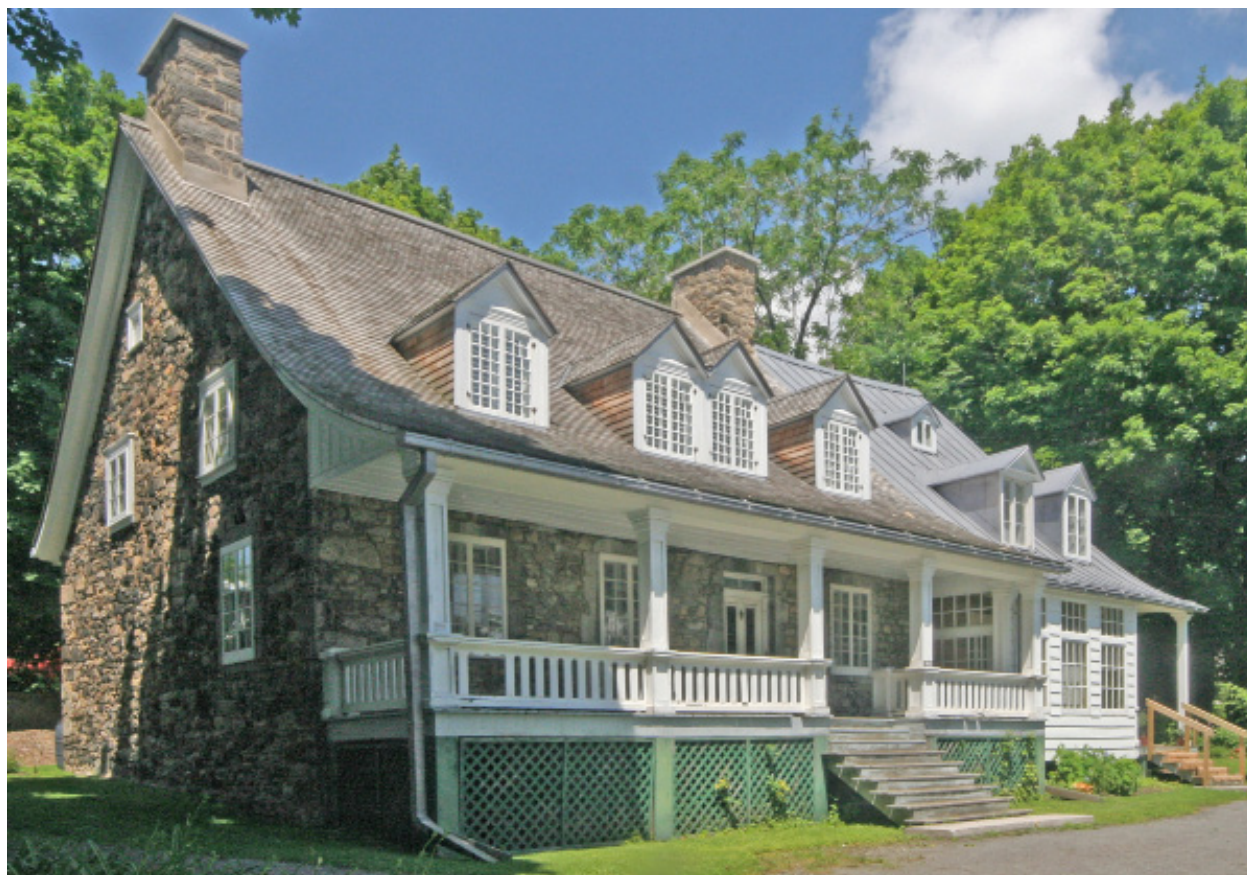
561-563 Cote-Saint Antoine Road

<i>Description:</i>	A semi-detached building where the South (principal) and West façades are of importance. Heritage value derives from Historic Value related to age and to Urban Value related to setting. The Barn is of heritage value. The Hurtubise House and its site is a classified monument (MCCCCFQ)
<i>Date of construction:</i>	Mid-18th century for main house (563); End 19th century for addition (561)
<i>Persons associated with:</i>	Hurtubise family
<i>Stylistic influences:</i>	“Canadien” farmhouse (vernacular)
<i>Materials:</i>	
<i>Cladding (HCDE):</i>	Limestone fieldstone, originally covered in stucco (main house: 563) Brick (Addition: 561)
<i>Roof (HCDE):</i>	Pitched roof, now covered in cedar shingles on main house (563); Sheet metal on addition (561)
<i>Windows (HCDE):</i>	Wood, original
<i>Woodwork (HCDE):</i>	Including gallery (Existing gallery not original and not HCDE in itself.)
<i>Composition:</i>	Building now has central pavilion with wing. Central pavilion is symmetrical about the entrance door. The wing, housing the original summer kitchen, is of lesser value and could be subject to change.

<i>Integrity:</i>	High, in an evolutionary sense that is generally associated with vernacular architecture. A front gallery has existed on the main pavilion since the mid-19th century. However, the present one is a combination of historic elements and new ones and must be researched before modifications can be done.
	NOTE: chimneys HCDE

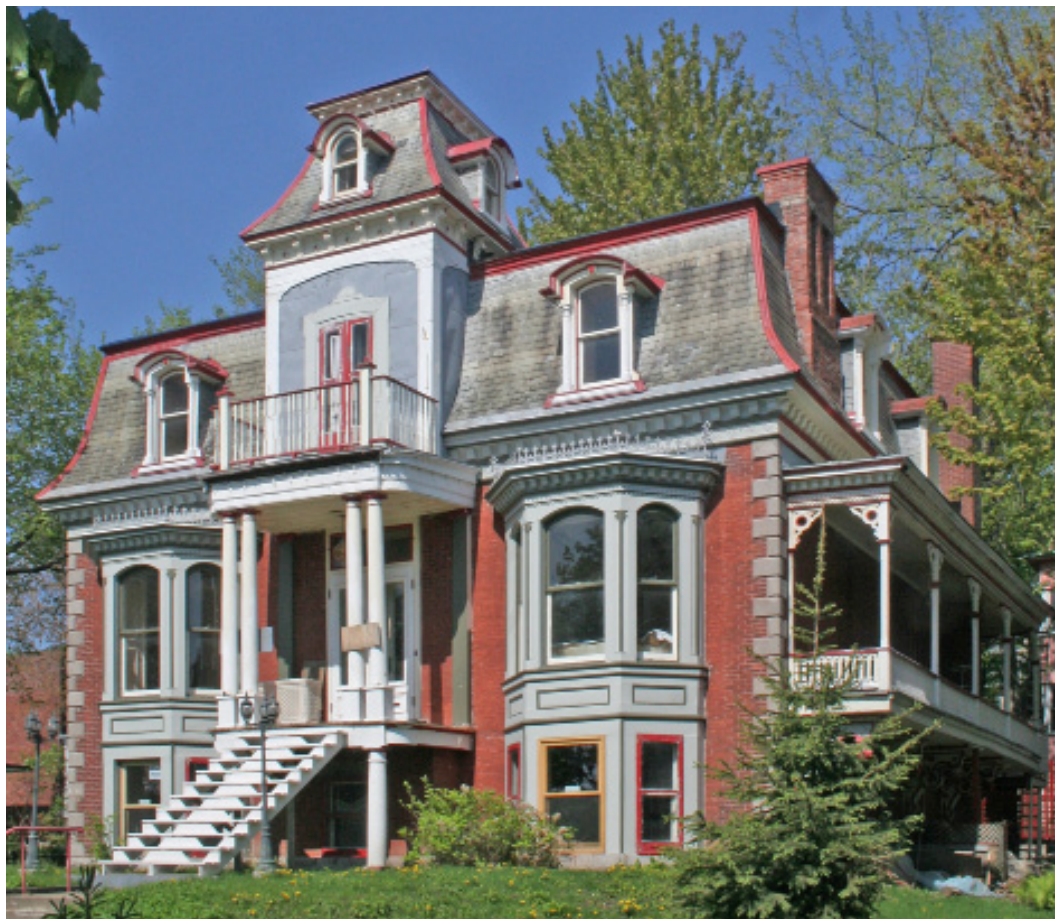
649 Cote-Saint Antoine Road

Description: Detached building: all 4 façades of importance, but principal façade of greatest value. Heritage value derives from Historic Value related to age; and Artistic Value, related to architecture, and Urban Value related to remarkable garden setting.

Roof (HCDE): Slate Mansard with cornice (Probably cresting missing)

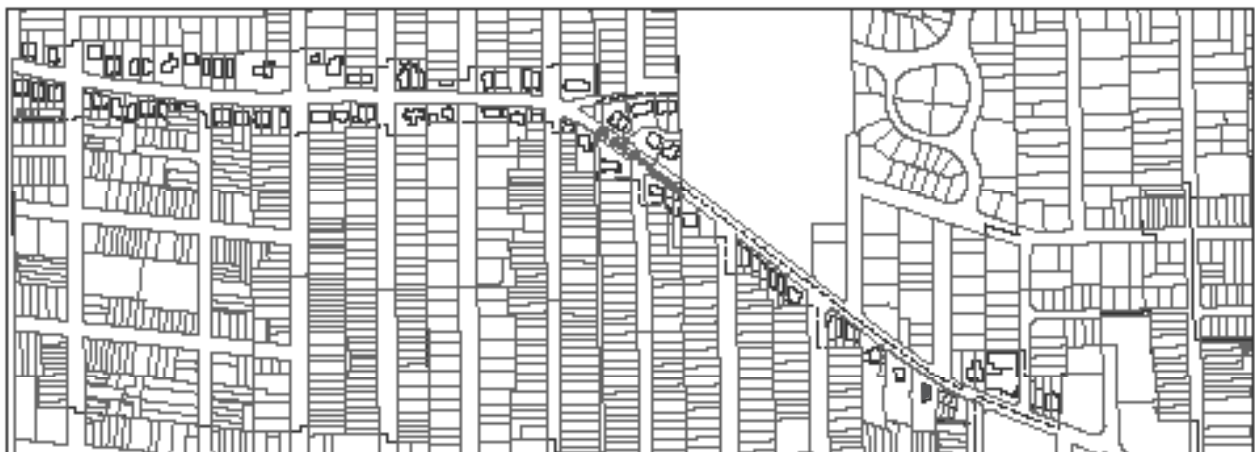
<i>Description:</i>	A detached building where all 4 façades are of importance. Heritage value derives from Historic Value related to age; Artistic Value, related to architecture and architects, and Urban Value related to remarkable garden setting (Note: 168 is one of two remaining houses of an ensemble of four).
<i>Date of construction:</i>	1840
<i>Persons associated with:</i>	Moses Judah Hayes
<i>Stylistic influences:</i>	Neo-Classical villa with Neo-Grec ornamentation.
<i>Materials:</i>	
<i>Cladding (HCDE):</i>	Limestone fieldstone covered in stucco
<i>Roof (HCDE):</i>	Mansard in slate: roof is not original, but probably mid-19th century
<i>Windows (HCDE):</i>	Wood, original
<i>Woodwork (HCDE):</i>	Window hoods, pilasters and porch
<i>Composition:</i>	The composition is not rigidly symmetrical, in that the door is off-axis. However, all windows are aligned. The cubic form is governing.
<i>Integrity:</i>	High

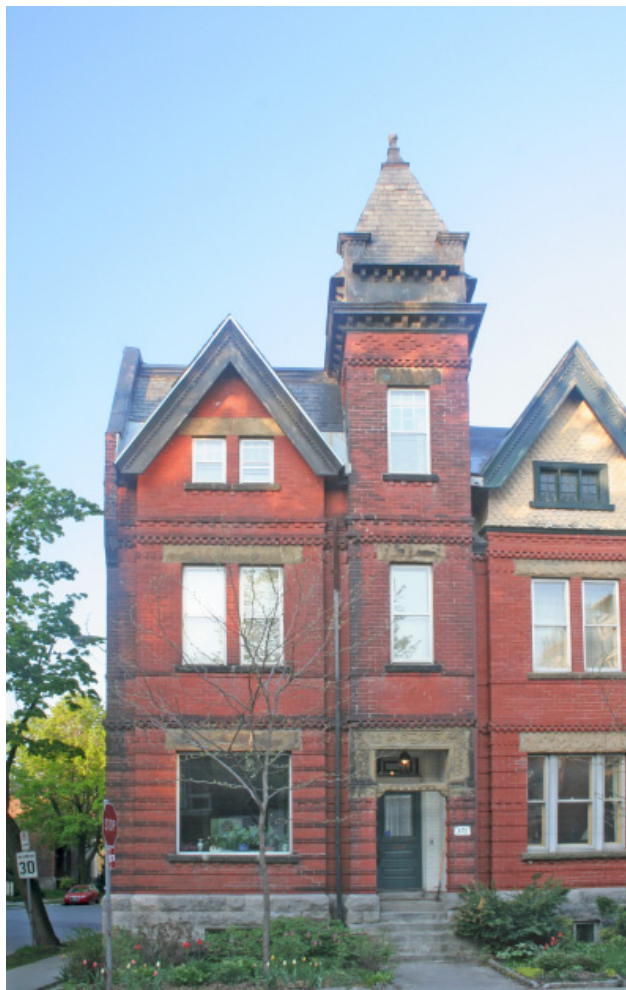
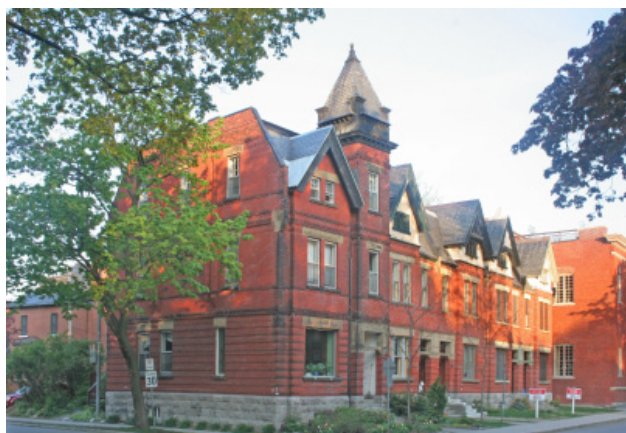
376 Metcalfe Road

<i>Description:</i>	This building is part of a terrace where only the front façade is of importance. Heritage value derives from Historic Values related to age, Artistic Value related to Queen Anne Revival style; integrity of entire terrace.
<i>Date of construction:</i>	1896
<i>Persons associated with:</i>	H.L. Penny
<i>Stylistic influences:</i>	Queen Anne Revival
<i>Materials:</i>	
<i>Cladding (HCDE):</i>	Red brick with Miramichi ochre trim
<i>Roof (HCDE):</i>	Slate
<i>Windows (HCDE):</i>	Wood; original
<i>Woodwork (HCDE):</i>	Doors; there is little woodwork on the buildings, almost all trim is in sandstone
<i>Composition:</i>	This terrace housing is made up of a double unit which is repeated and ended with a tower unit. In consequence of massing principles, neo-classical principles of symmetry are suppressed in the overall composition, in favour of series of vertical compositions. The windows are placed symmetrically in these compositions. However, this approach is less rigorous on the Melbourne facade, and lacking on rear façade.

<i>Masonry:</i>	Exceptional quality of brickwork, combined with sandstone trim. Geometric patterning of brickwork characteristic of the Style (diapering, banding, corbelling). Brickwork used to divide wall into bands, corresponding to floor levels. This division further emphasized by the use of shingling in gable. The use of extremely thin mortar joints contributes to the uniformity of the masonry. Use of coloured mortar (red) contributes to the uniformity of the brickwork.
<i>Colour Palette:</i>	Colour palette of warm, contrasting earth tones: red brick, ochre sandstone, slate roofing. Colour used, like brickwork, to emphasize banding of wall surface.
<i>Massing:</i>	Variety of treatments enlivens façade: use of tower forms, dormers. Identity of individual dwelling units is suppressed for benefit of the overall composition.
<i>Integrity:</i>	High
	NOTE: The rear façades are of much less significance and integrity, and could be subject to greater change.

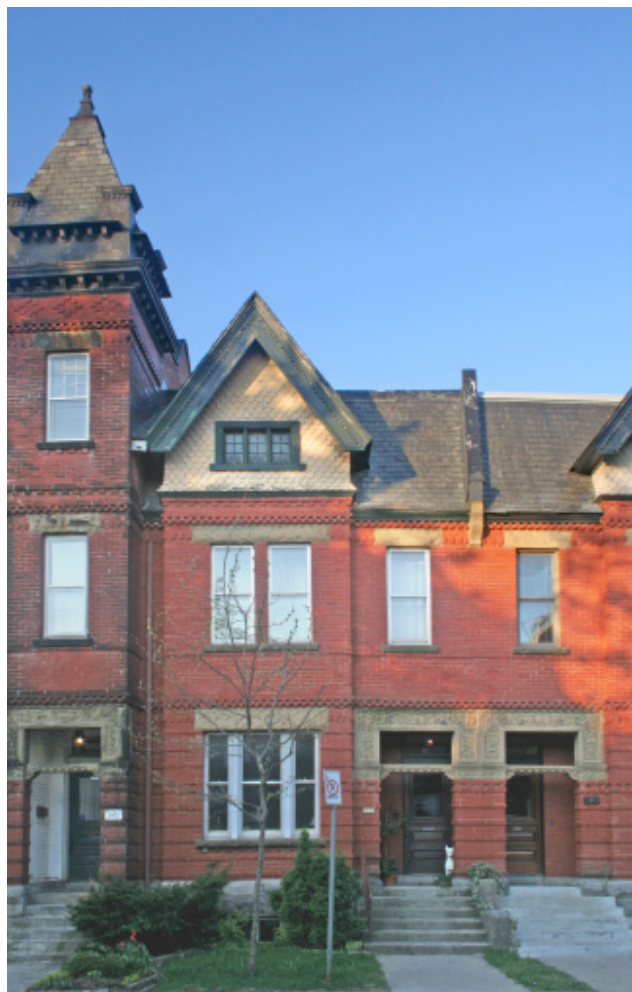
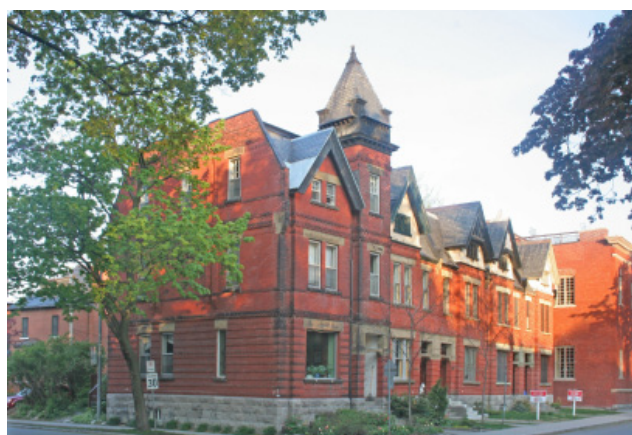
378 Metcalfe Road

<i>Description:</i>	This building is part of a terrace where only the front façade is of importance. Heritage value derives from Historic Values related to age, Artistic Value related to Queen Anne Revival style; integrity of entire terrace.
<i>Date of construction:</i>	1896
<i>Persons associated with:</i>	H.L. Penny
<i>Stylistic influences:</i>	Queen Anne Revival
<i>Materials:</i>	
<i>Cladding (HCDE):</i>	Red brick with Miramichi ochre trim
<i>Roof (HCDE):</i>	Slate
<i>Windows (HCDE):</i>	Wood; original
<i>Woodwork (HCDE):</i>	Doors; there is little woodwork on the buildings, almost all trim is in sandstone
<i>Composition:</i>	This terrace housing is made up of a double unit which is repeated and ended with a tower unit. In consequence of massing principles, neo-classical principles of symmetry are suppressed in the overall composition, in favour of series of vertical compositions. The windows are placed symmetrically in these compositions. However, this approach is less rigorous on the Melbourne façade, and lacking on rear façade.

<i>Masonry:</i>	Exceptional quality of brickwork, combined with sandstone trim. Geometric patterning of brickwork characteristic of the Style (diapering, banding, corbelling). Brickwork used to divide wall into bands, corresponding to floor levels. This division further emphasized by the use of shingling in gable. The use of extremely thin mortar joints contributes to the uniformity of the masonry. Use of coloured mortar (red) contributes to the uniformity of the brickwork.
<i>Colour Palette:</i>	Colour palette of warm, contrasting earth tones: red brick, ochre sandstone, slate roofing. Colour used, like brickwork, to emphasize banding of wall surface.
<i>Massing:</i>	Variety of treatments enlivens facade: use of tower forms, dormers. Identity of individual dwelling units is suppressed for benefit of the overall composition.
<i>Integrity:</i>	High
	NOTE: The rear façades are of much less significance and integrity, and could be subject to greater change.

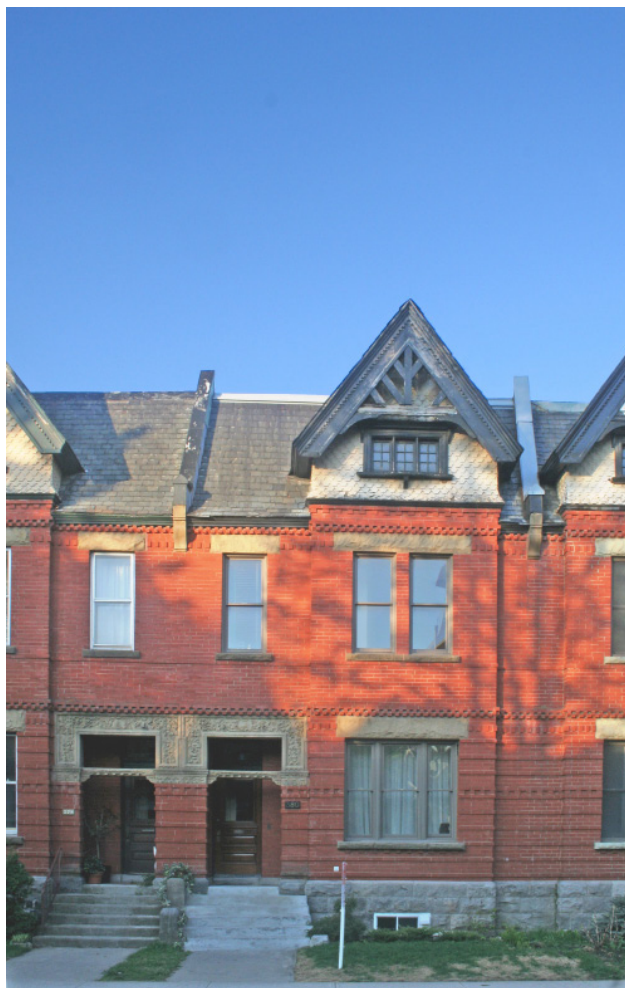
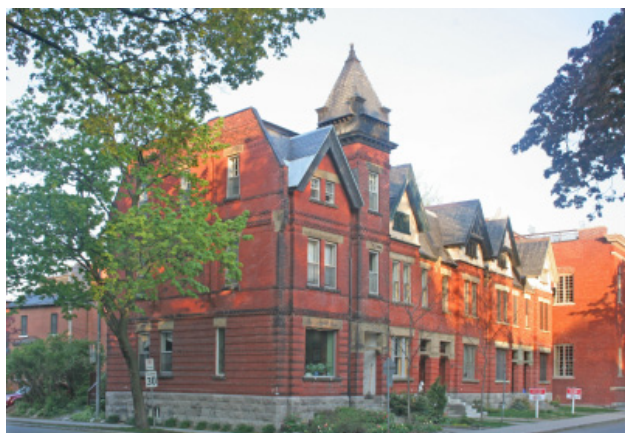
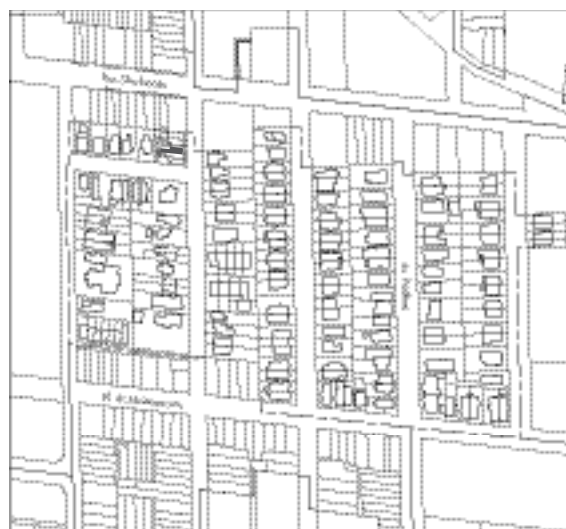
380 Metcalfe Road

<i>Description:</i>	This building is part of a terrace where only the front façade is of importance. Heritage value derives from Historic Values related to age, Artistic Value related to Queen Anne Revival style; integrity of entire terrace.
<i>Date of construction:</i>	1896
<i>Persons associated with:</i>	H.L. Penny
<i>Stylistic influences:</i>	Queen Anne Revival
<i>Materials:</i>	
<i>Cladding (HCDE):</i>	Red brick with Miramichi ochre trim
<i>Roof (HCDE):</i>	Slate
<i>Windows (HCDE):</i>	Wood; original
<i>Woodwork (HCDE):</i>	Doors; there is little woodwork on the buildings, almost all trim is in sandstone
<i>Composition:</i>	This terrace housing is made up of a double unit which is repeated and ended with a tower unit. In consequence of massing principles, neo-classical principles of symmetry are suppressed in the overall composition, in favour of series of vertical compositions. The windows are placed symmetrically in these compositions. However, this approach is less rigorous on the Melbourne façade, and lacking on rear façade.

<i>Masonry:</i>	Exceptional quality of brickwork, combined with sandstone trim. Geometric patterning of brickwork characteristic of the Style (diapering, banding, corbelling). Brickwork used to divide wall into bands, corresponding to floor levels. This division further emphasized by the use of shingling in gable. The use of extremely thin mortar joints contributes to the uniformity of the masonry. Use of coloured mortar (red) contributes to the uniformity of the brickwork.
<i>Colour Palette:</i>	Colour palette of warm, contrasting earth tones: red brick, ochre sandstone, slate roofing. Colour used, like brickwork, to emphasize banding of wall surface.
<i>Massing:</i>	Variety of treatments enlivens façade: use of tower forms, dormers. Identity of individual dwelling units is suppressed for benefit of the overall composition.
<i>Integrity:</i>	High
	NOTE: The rear façades are of much less significance and integrity, and could be subject to greater change.

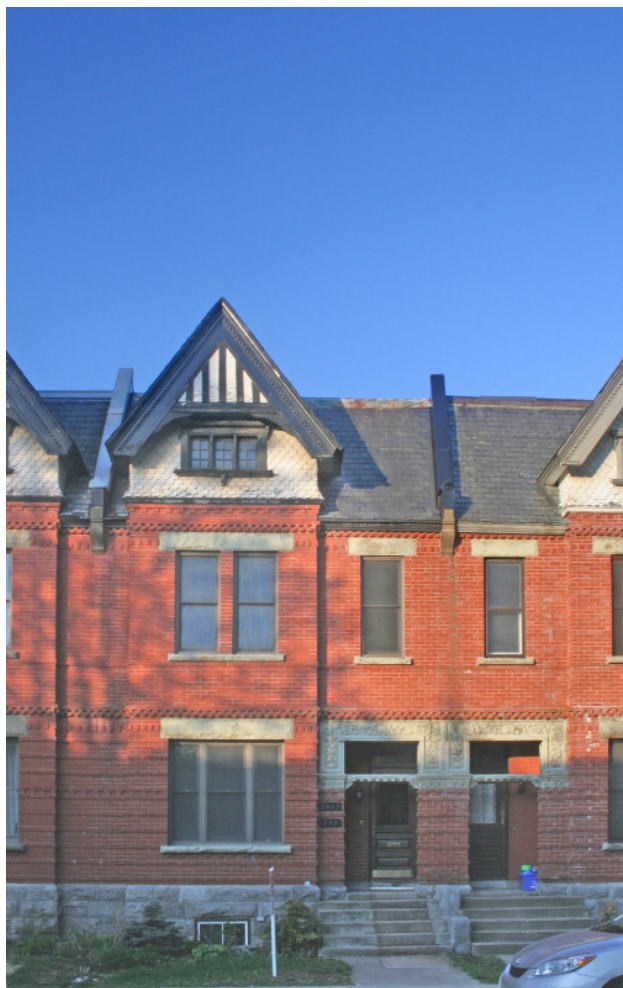
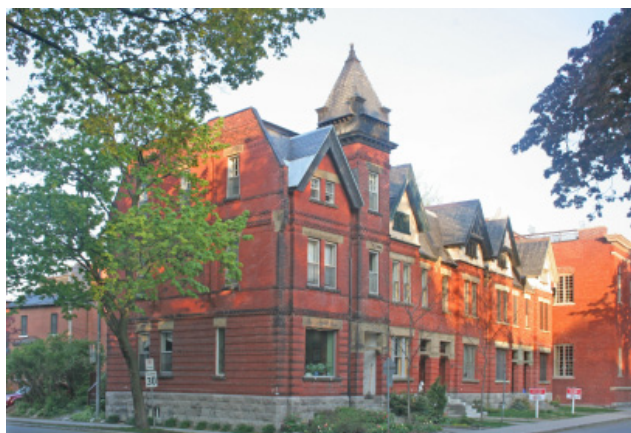
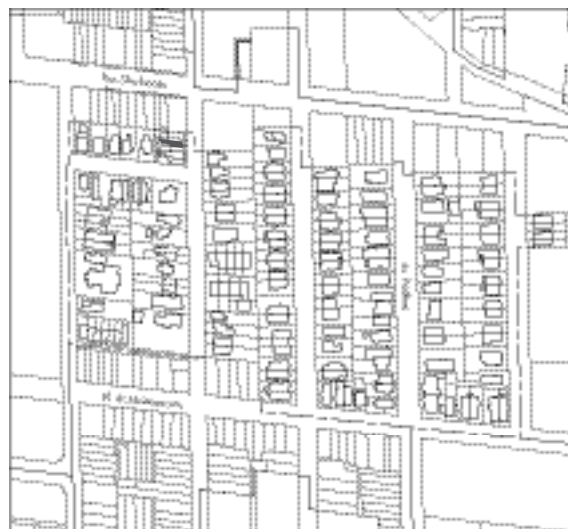
382 Metcalfe Road

<i>Description:</i>	This building is part of a terrace where only the front façade is of importance. Heritage value derives from Historic Values related to age, Artistic Value related to Queen Anne Revival style; integrity of entire terrace.
<i>Date of construction:</i>	1896
<i>Persons associated with:</i>	H.L. Penny
<i>Stylistic influences:</i>	Queen Anne Revival
<i>Materials:</i>	
<i>Cladding (HCDE):</i>	Red brick with Miramichi ochre trim
<i>Roof (HCDE):</i>	Slate
<i>Windows (HCDE):</i>	Wood; original
<i>Woodwork (HCDE):</i>	Doors; there is little woodwork on the buildings, almost all trim is in sandstone
<i>Composition:</i>	This terrace housing is made up of a double unit which is repeated and ended with a tower unit. In consequence of massing principles, neo-classical principles of symmetry are suppressed in the overall composition, in favour of series of vertical compositions. The windows are placed symmetrically in these compositions. However, this approach is less rigorous on the Melbourne façade, and lacking on rear façade.

<i>Masonry:</i>	Exceptional quality of brickwork, combined with sandstone trim. Geometric patterning of brickwork characteristic of the Style (diapering, banding, corbelling). Brickwork used to divide wall into bands, corresponding to floor levels. This division further emphasized by the use of shingling in gable. The use of extremely thin mortar joints contributes to the uniformity of the masonry. Use of coloured mortar (red) contributes to the uniformity of the brickwork.
<i>Colour Palette:</i>	Colour palette of warm, contrasting earth tones: red brick, ochre sandstone, slate roofing. Colour used, like brickwork, to emphasize banding of wall surface.
<i>Massing:</i>	Variety of treatments enlivens façade: use of tower forms, dormers. Identity of individual dwelling units is suppressed for benefit of the overall composition.
<i>Integrity:</i>	High
	NOTE: The rear façades are of much less significance and integrity, and could be subject to greater change.

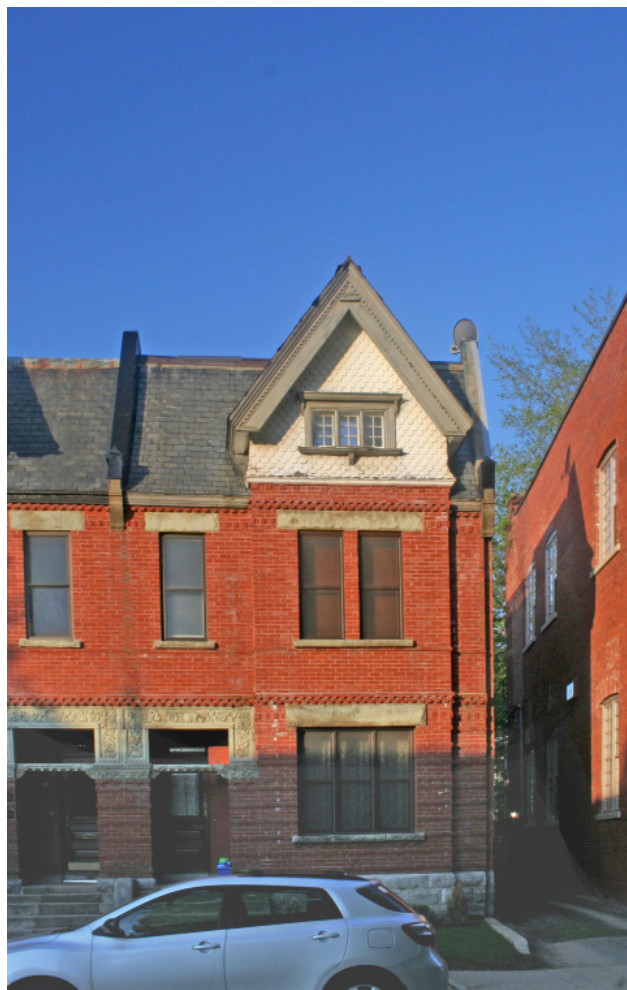
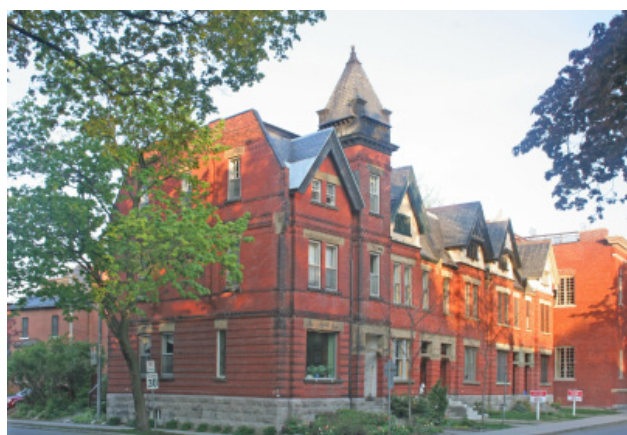
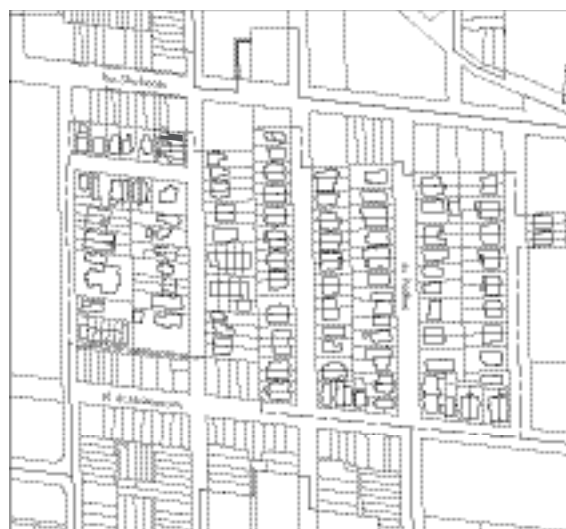
384 Metcalfe Road

<i>Description:</i>	This building is part of a terrace where only the front façade is of importance. Heritage value derives from Historic Values related to age, Artistic Value related to Queen Anne Revival style; integrity of entire terrace.
<i>Date of construction:</i>	1896
<i>Persons associated with:</i>	H.L. Penny
<i>Stylistic influences:</i>	Queen Anne Revival
<i>Materials:</i>	
<i>Cladding (HCDE):</i>	Red brick with Miramichi ochre trim
<i>Roof (HCDE):</i>	Slate
<i>Windows (HCDE):</i>	Wood; original
<i>Woodwork (HCDE):</i>	Doors; there is little woodwork on the buildings, almost all trim is in sandstone
<i>Composition:</i>	This terrace housing is made up of a double unit which is repeated and ended with a tower unit. In consequence of massing principles, neo-classical principles of symmetry are suppressed in the overall composition, in favour of series of vertical compositions. The windows are placed symmetrically in these compositions. However, this approach is less rigorous on the Melbourne facade, and lacking on rear façade.

<i>Masonry:</i>	Exceptional quality of brickwork, combined with sandstone trim. Geometric patterning of brickwork characteristic of the Style (diapering, banding, corbelling). Brickwork used to divide wall into bands, corresponding to floor levels. This division further emphasized by the use of shingling in gable. The use of extremely thin mortar joints contributes to the uniformity of the masonry. Use of coloured mortar (red) contributes to the uniformity of the brickwork.
<i>Colour Palette:</i>	Colour palette of warm, contrasting earth tones: red brick, ochre sandstone, slate roofing. Colour used, like brickwork, to emphasize banding of wall surface.
<i>Massing:</i>	Variety of treatments enlivens façade: use of tower forms, dormers. Identity of individual dwelling units is suppressed for benefit of the overall composition.
<i>Integrity:</i>	High
	NOTE: The rear façades are of much less significance and integrity, and could be subject to greater change.

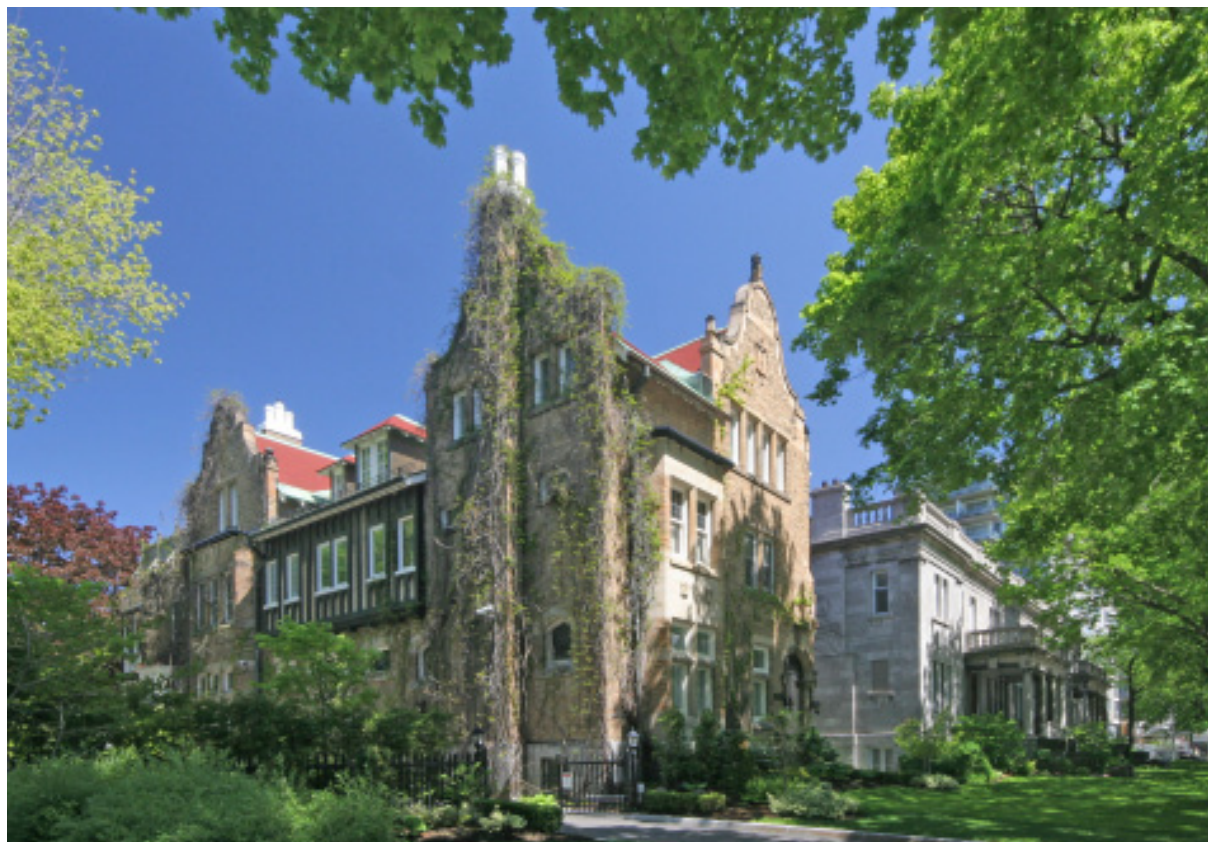
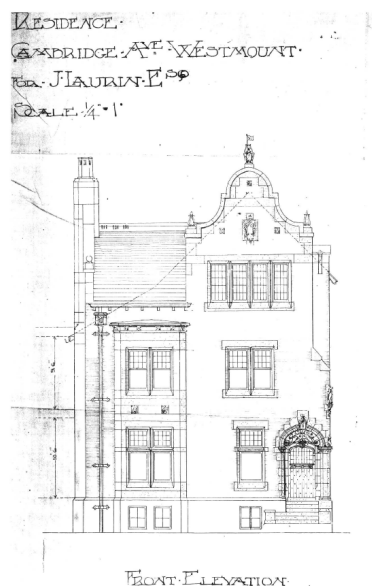
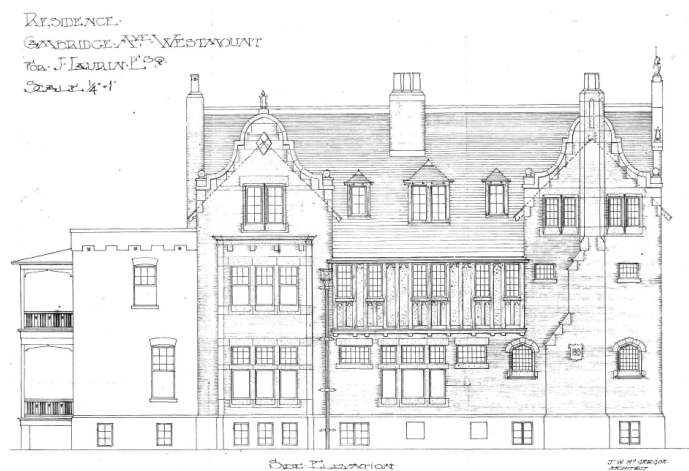
327 Redfern Avenue

West Elevation, 1919

<i>Description:</i>	A detached building where all 4 façades are of importance. Heritage value derives from Historic Value related to age; and Artistic Value, related to architecture and architects, and Urban Value related to garden setting.
<i>Date of construction:</i>	1913; 1939-66 various alterations
<i>Persons associated with:</i>	James Laurin, owner; J.W. McGregor, architect
<i>Stylistic influences:</i>	Various: Dutch gable, Neo-Renaissance detailing
<i>Materials:</i>	
<i>Cladding (HCDE):</i>	Beige brick with limestone trim
<i>Roof (HCDE):</i>	Red slate with copper flashings
<i>Windows (HCDE):</i>	Wood, original
<i>Woodwork (HCDE):</i>	Little woodwork, most of trim in stone
<i>Composition:</i>	Asymmetry and variety is an essential HCDE.
<i>Integrity:</i>	High
	NOTE: chimneys HCDE

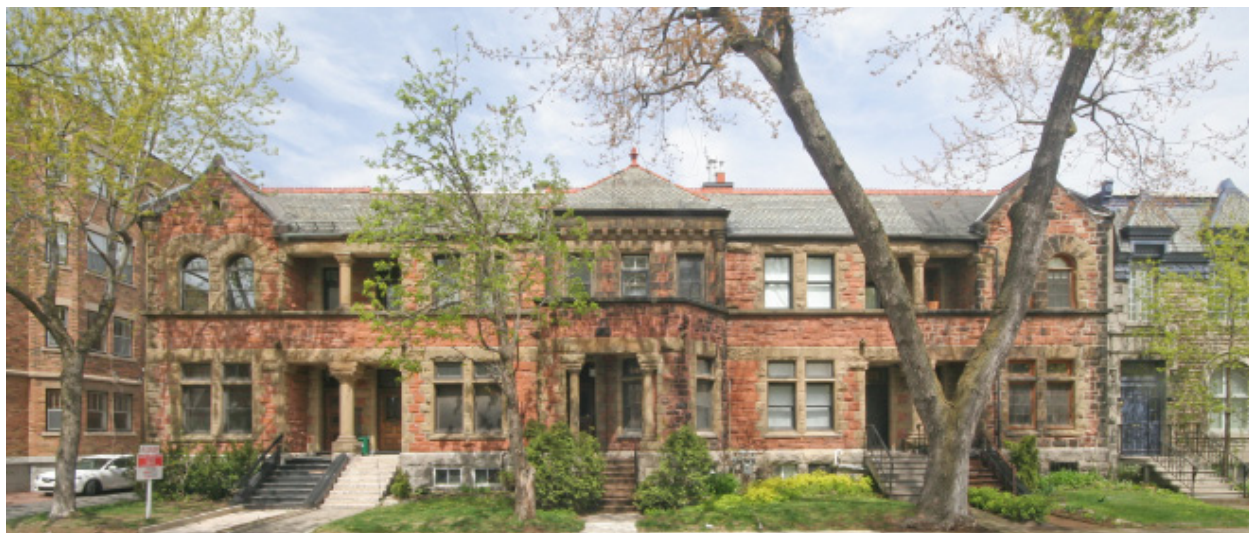
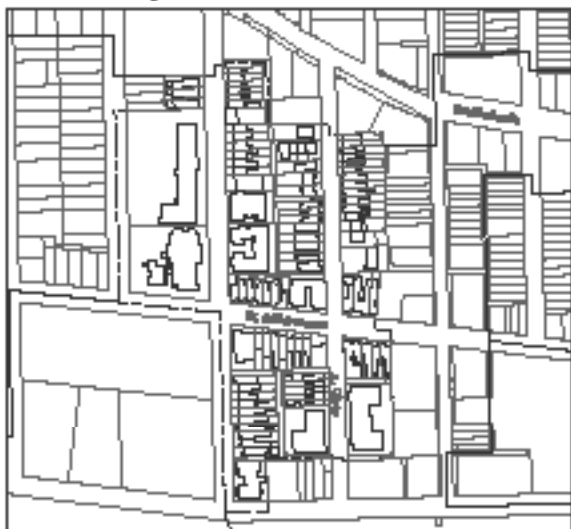
373 Olivier Avenue

<i>Description:</i>	This building is part of a terrace, only the front façade is of importance. Heritage value derives from Historic Values related to age, Artistic Value related to Richardsonian Romanesque style; associations with A.C. Hutchison.
<i>Date of construction:</i>	1892
<i>Persons associated with:</i>	Simpson and Peel (developers); A.C. Hutchison, architect
<i>Stylistic influences:</i>	Richardsonian Romanesque
<i>Materials:</i>	
<i>Cladding (HCDE):</i>	Scottish red sandstone with Miramichi ochre trim
<i>Roof (HCDE):</i>	Slate
<i>Windows (HCDE):</i>	Wood; not original
<i>Woodwork (HCDE):</i>	Doors; there is little woodwork on the buildings, almost all trim is in sandstone
<i>Composition:</i>	The overall composition of the 5 unit terrace housing is symmetrical, about a central tower. Within this framework, each unit, aside from the central one (379) has an asymmetrical composition.
<i>Integrity:</i>	High

NOTE: The rear façades are of much less significance and integrity, and could be subject to greater change.
