City of Westmount

Heritage Character Defining Elements:
Category 1★ Buildings

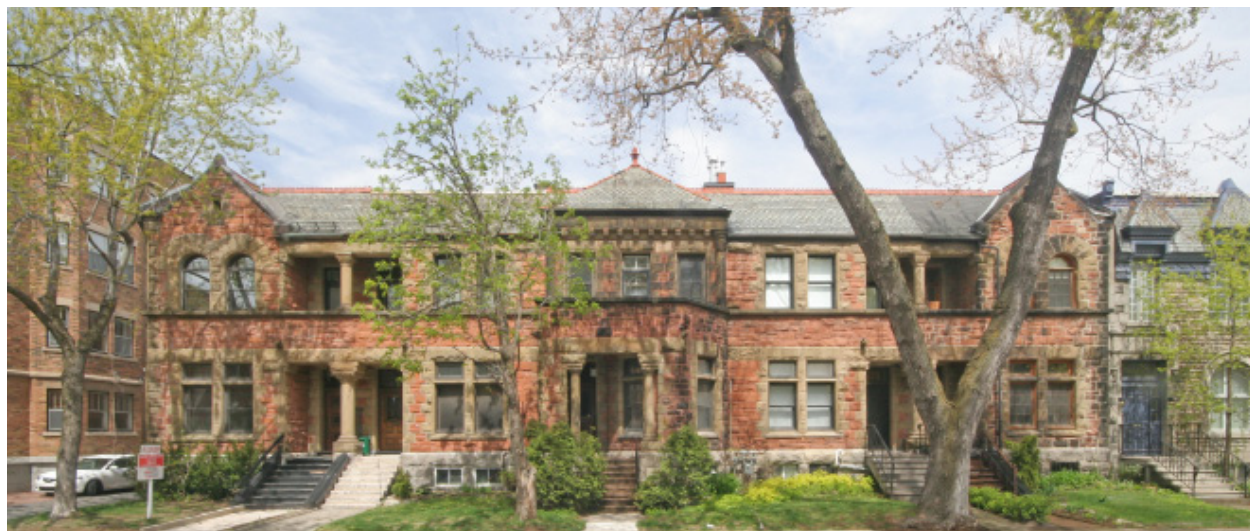
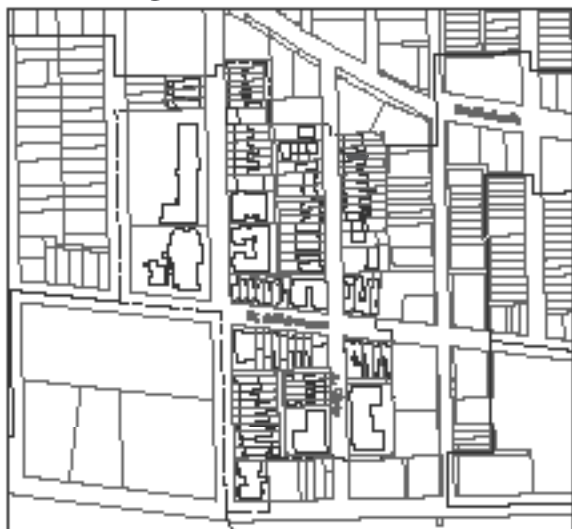
375 Olivier Avenue

<i>Description:</i>	This building is part of a terrace, only the front façade is of importance. Heritage value derives from Historic Values related to age, Artistic Value related to Richardsonian Romanesque style; associations with A.C. Hutchison.
<i>Date of construction:</i>	1892
<i>Persons associated with:</i>	Simpson and Peel (developers); A.C. Hutchison, architect
<i>Stylistic influences:</i>	Richardsonian Romanesque
<i>Materials:</i>	
<i>Cladding (HCDE):</i>	Scottish red sandstone with Miramichi ochre trim
<i>Roof (HCDE):</i>	Slate
<i>Windows (HCDE):</i>	Wood; not original
<i>Woodwork (HCDE):</i>	Doors; there is little woodwork on the buildings, almost all trim is in sandstone
<i>Composition:</i>	The overall composition of the 5 unit terrace housing is symmetrical, about a central tower. Within this framework, each unit, aside from the central one (379) has an asymmetrical composition.
<i>Integrity:</i>	High

NOTE: The rear façades are of much less significance and integrity, and could be subject to greater change.

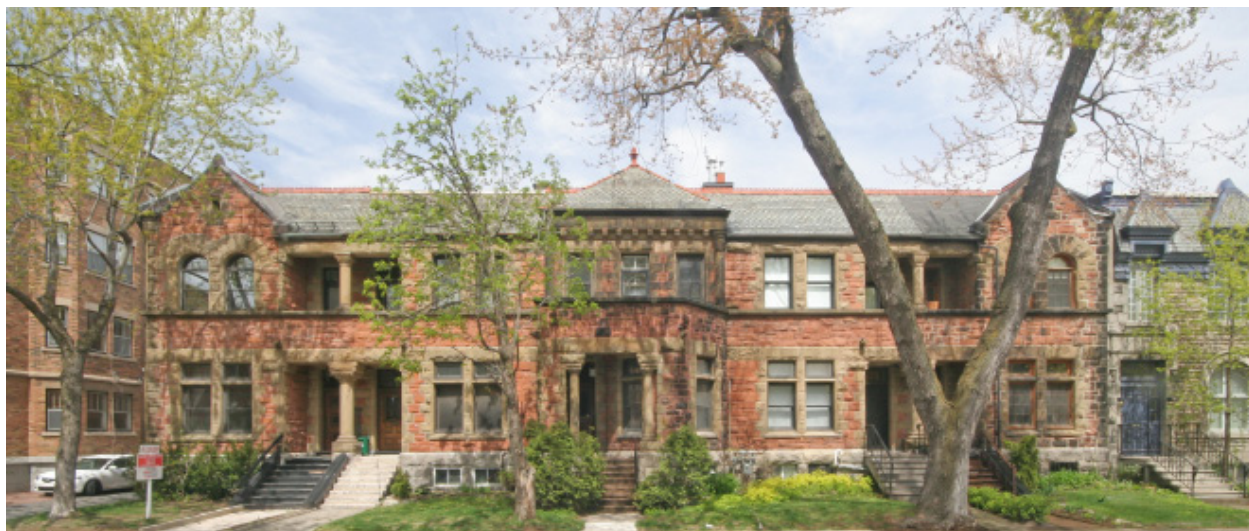
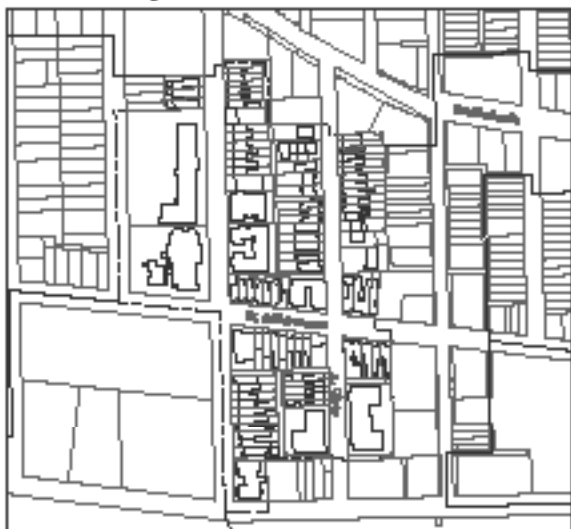
379 Olivier Avenue

<i>Description:</i>	This building is part of a terrace, only the front façade is of importance. Heritage value derives from Historic Values related to age, Artistic Value related to Richardsonian Romanesque style; associations with A.C. Hutchison.
<i>Date of construction:</i>	1892
<i>Persons associated with:</i>	Simpson and Peel (developers); A.C. Hutchison, architect
<i>Stylistic influences:</i>	Richardsonian Romanesque
<i>Materials:</i>	
<i>Cladding (HCDE):</i>	Scottish red sandstone with Miramichi ochre trim
<i>Roof (HCDE):</i>	Slate
<i>Windows (HCDE):</i>	Wood; not original
<i>Woodwork (HCDE):</i>	Doors; there is little woodwork on the buildings, almost all trim is in sandstone
<i>Composition:</i>	The overall composition of the 5 unit terrace housing is symmetrical, about a central tower. Within this framework, each unit, aside from the central one (379) has an asymmetrical composition.
<i>Integrity:</i>	High

NOTE: The rear façades are of much less significance and integrity, and could be subject to greater change.

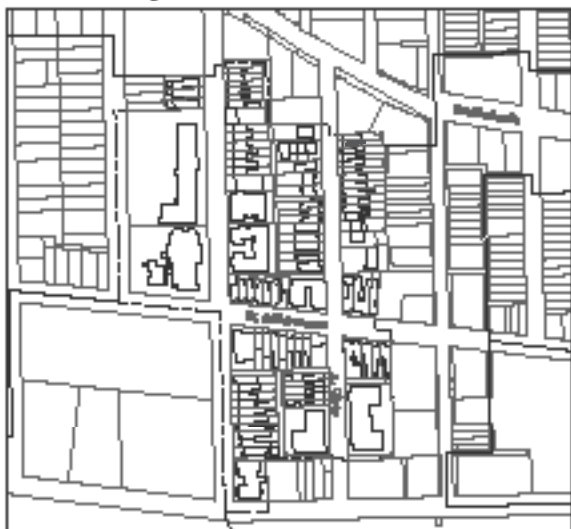
381 Olivier Avenue

<i>Description:</i>	This building is part of a terrace, only the front façade is of importance. Heritage value derives from Historic Values related to age, Artistic Value related to Richardsonian Romanesque style; associations with A.C. Hutchison.
<i>Date of construction:</i>	1892
<i>Persons associated with:</i>	Simpson and Peel (developers); A.C. Hutchison, architect
<i>Stylistic influences:</i>	Richardsonian Romanesque
<i>Materials:</i>	
<i>Cladding (HCDE):</i>	Scottish red sandstone with Miramichi ochre trim
<i>Roof (HCDE):</i>	Slate
<i>Windows (HCDE):</i>	Wood; not original
<i>Woodwork (HCDE):</i>	Doors; there is little woodwork on the buildings, almost all trim is in sandstone
<i>Composition:</i>	The overall composition of the 5 unit terrace housing is symmetrical, about a central tower. Within this framework, each unit, aside from the central one (379) has an asymmetrical composition.
<i>Integrity:</i>	High

NOTE: The rear façades are of much less significance and integrity, and could be subject to greater change.

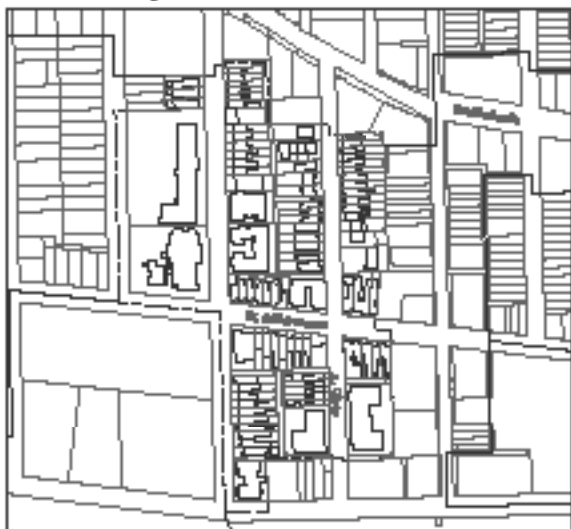
383 Olivier Avenue

<i>Description:</i>	This building is part of a terrace, only the front façade is of importance. Heritage value derives from Historic Values related to age, Artistic Value related to Richardsonian Romanesque style; associations with A.C. Hutchison.
<i>Date of construction:</i>	1892
<i>Persons associated with:</i>	Simpson and Peel (developers); A.C. Hutchison, architect
<i>Stylistic influences:</i>	Richardsonian Romanesque
<i>Materials:</i>	
<i>Cladding (HCDE):</i>	Scottish red sandstone with Miramichi ochre trim
<i>Roof (HCDE):</i>	Slate
<i>Windows (HCDE):</i>	Wood; not original
<i>Woodwork (HCDE):</i>	Doors; there is little woodwork on the buildings, almost all trim is in sandstone
<i>Composition:</i>	The overall composition of the 5 unit terrace housing is symmetrical, about a central tower. Within this framework, each unit, aside from the central one (379) has an asymmetrical composition.
<i>Integrity:</i>	High

NOTE: The rear façades are of much less significance and integrity, and could be subject to greater change.

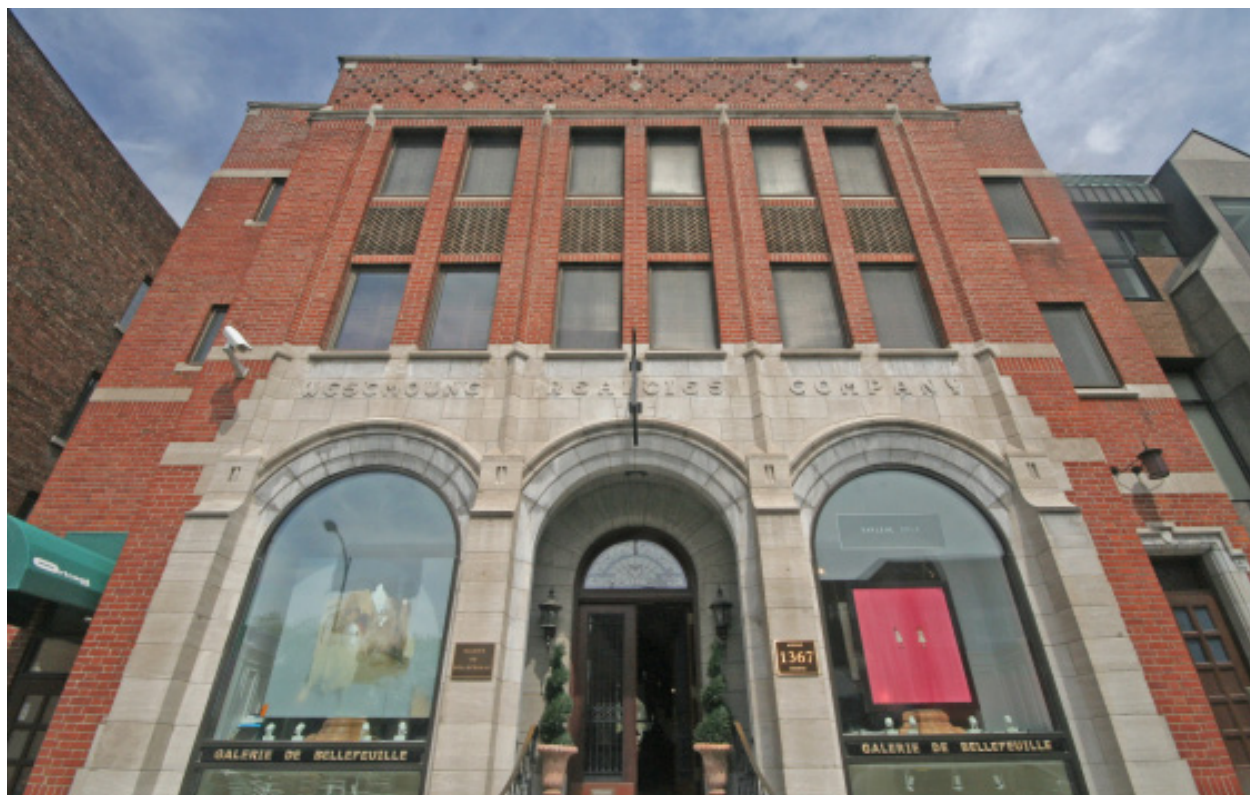
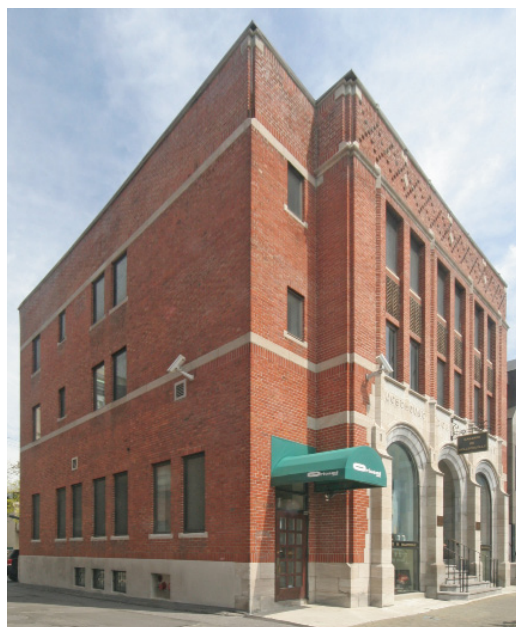
1365/1367 Greene Avenue

<i>Description:</i>	Detached building; street façade is of importance. To a lesser degree, the lane façade has value; the rear façade has been substantially altered and has no heritage value. Heritage value derives from Artistic Value, related to architecture and architects, and Urban Value related to prominent presence on street.
<i>Date of construction:</i>	1927
<i>Persons associated with:</i>	Westmount Realities Co.; Lawson and Little, Architects
<i>Stylistic influences:</i>	Neo-classicism
<i>Materials:</i>	
<i>Cladding (HCDE):</i>	Brick upper storeys with stone trim; stone base
<i>Roof (HCDE):</i>	Flat
<i>Windows (HCDE):</i>	Not original and unfortunately lacking original sub-divisions; significant alterations to create shop windows The secondary door to the south is original, with a stone surround. The secondary door to the north, which leads to the basement shop is not original.
<i>Composition:</i>	The composition is symmetrical.

<i>Integrity:</i>	High
	NOTE: The rear façade is of much less significance and integrity, and could be subject to greater change.
